**CCR LANDFILL ANNUAL INSPECTION
BYPRODUCT STORAGE AREA
DECEMBER 2022**

Lakeland Electric

Golder Associates USA Inc.

January 2023

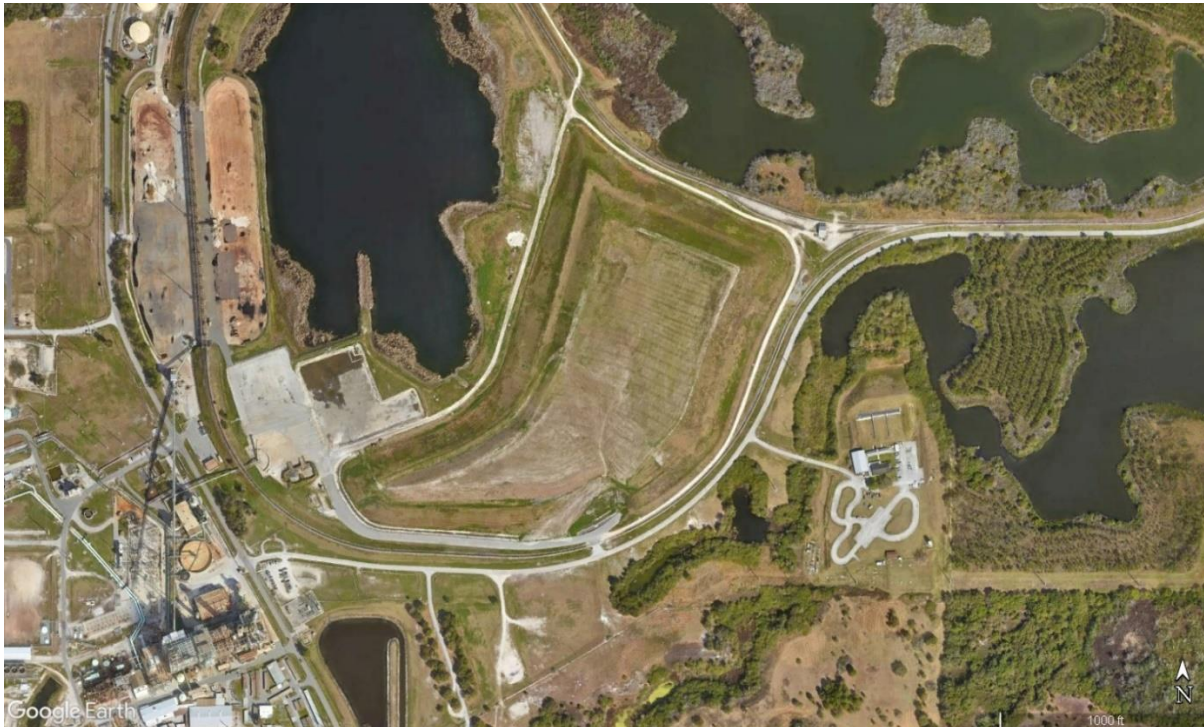
Figure 2: Figure 2 - Aerial Photograph (Google Earth²)

Changes in the geometry of the BSA were evaluated by comparing recent aerial photographs, past inspection results, past topography, and the December 22, 2021 visual inspection. The primary changes in geometry are due to material regrading and temporary capping of the BSA. Soil material stockpiles on the top of the northern portion were reclaimed and placed over CCRs in the southern portion of the BSA. A recent aerial photograph of the BSA is provided on Figure 2 (dated February 2022).
