**REPORT**

**CCR Landfill Annual Inspection  
Byproduct Storage Area  
December 2023**

*Lakeland Electric*

*C.D. McIntosh Power Plant*

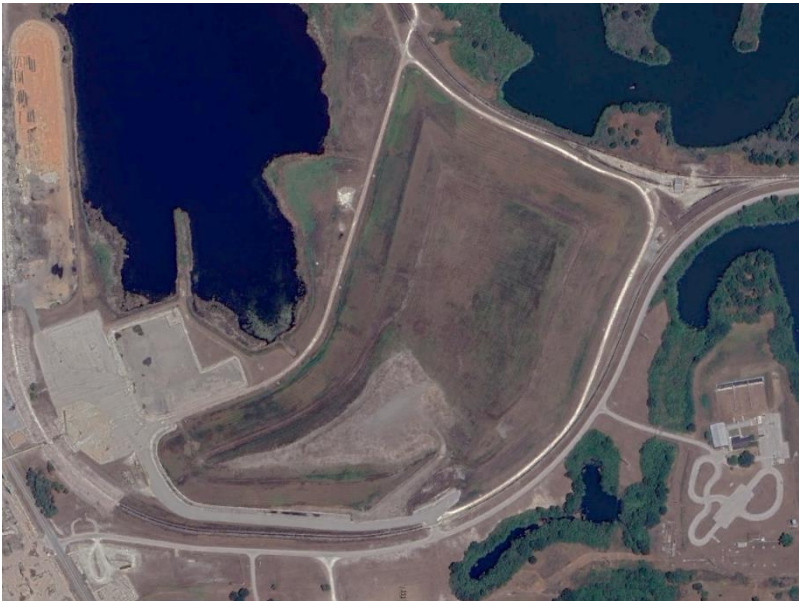
**Figure 2: Aerial Photograph (Google Earth<sup>2</sup>)**

Changes in the geometry of the BSA were evaluated by comparing recent aerial photographs, past inspection results, past topography, and the December 14, 2022 visual inspection. The primary changes in geometry are due to material regrading and temporary capping of the BSA. Soil material stockpiles on the top of the northern portion were reclaimed and placed over CCRs in the southern portion of the BSA. A recent aerial photograph of the BSA is provided on Figure 2 (dated April 2023).
