CCR LANDFILL ANNUAL INSPECTION REPORT BYPRODUCT STORAGE AREA DECEMBER 2020

Lakeland Electric

C.D. McIntosh Power Plant

19-133044

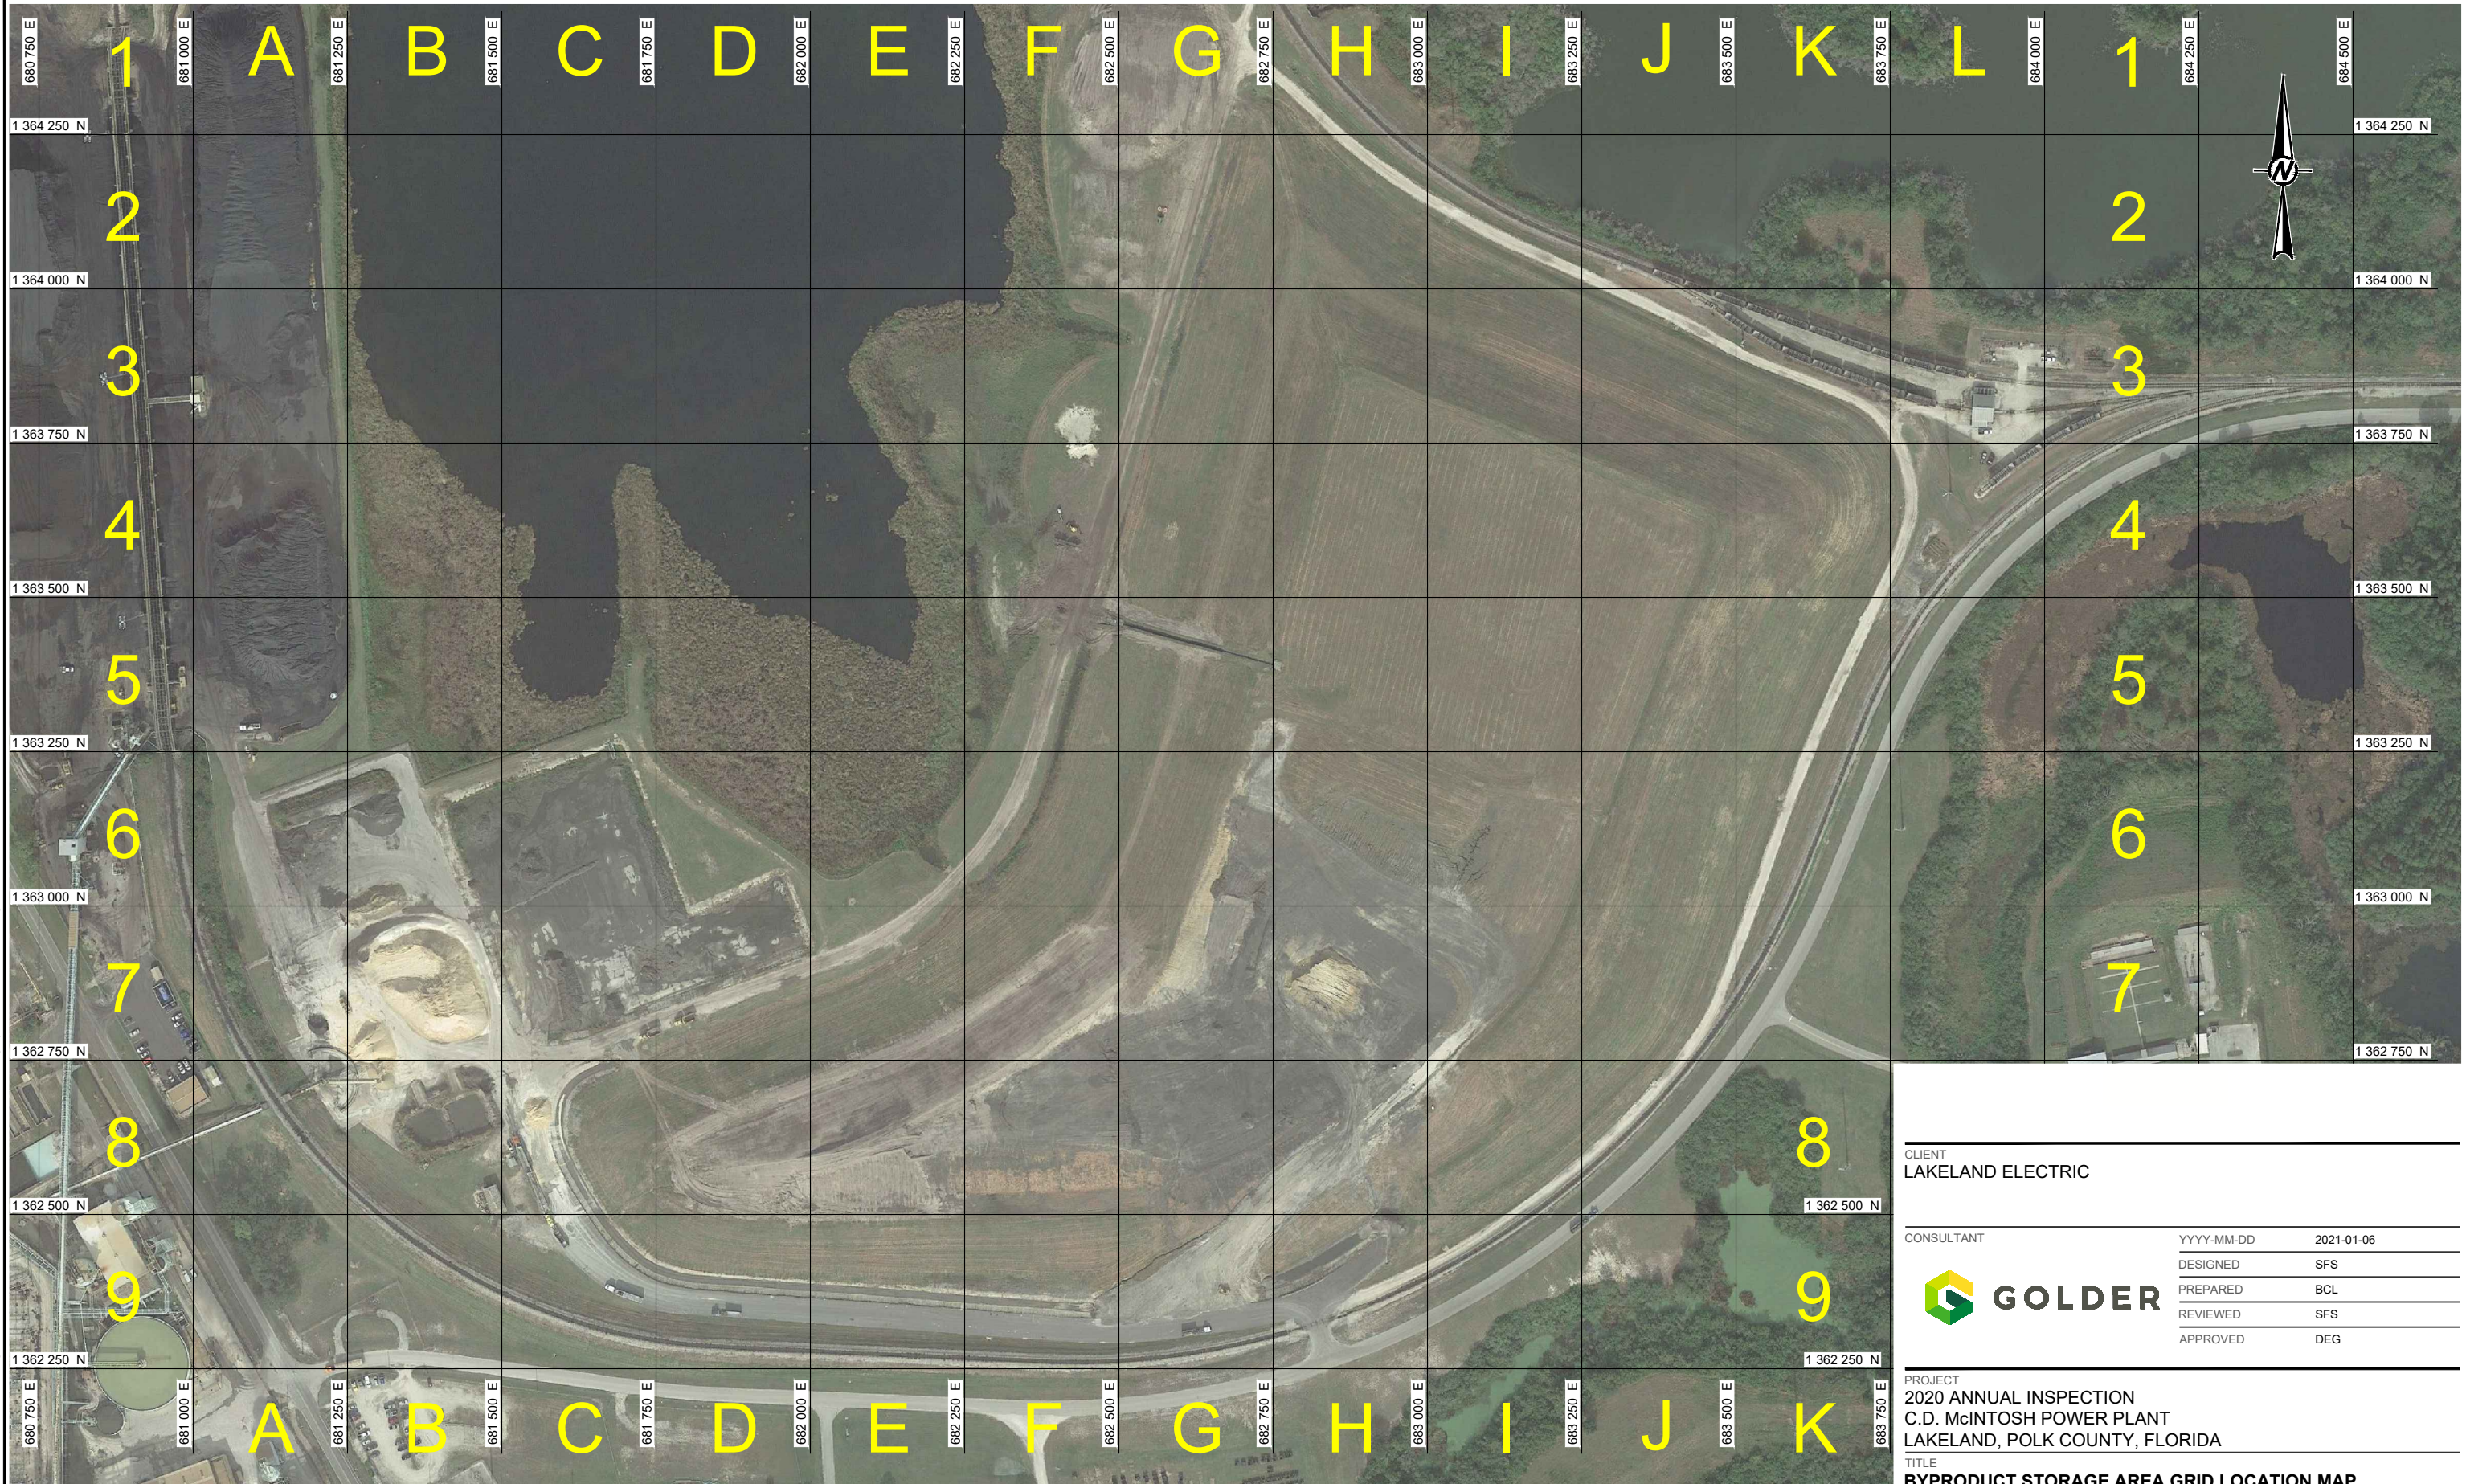
REFERENCE(S)
1. AERIAL IMAGERY SOURCE: GOOGLE EARTH® PRO 2010, IMAGE DATED 12.11.18. IMAGE GEOREFERENCED BY GOLDER AND INTENDED FOR INDICATIVE PURPOSES ONLY.

Changes in geometry of the BSA were evaluated by comparing recent aerial photographs, past inspection results, past topography and the December 5, 2019 visual inspection. The primary changes in geometry are due to material reclamation in the southern portion of the BSA and regrading of the top of the northern portion of the BSA.
