CCR LANDFILL ANNUAL INSPECTION BYPRODUCT STORAGE AREA DECEMBER 2021

Lakeland Electric C.D. McIntosh Power Plant 3030 East Lake Parker Drive Lakeland, Florida

Golder Associates USA Inc. 15851 South US 27, Suite 50

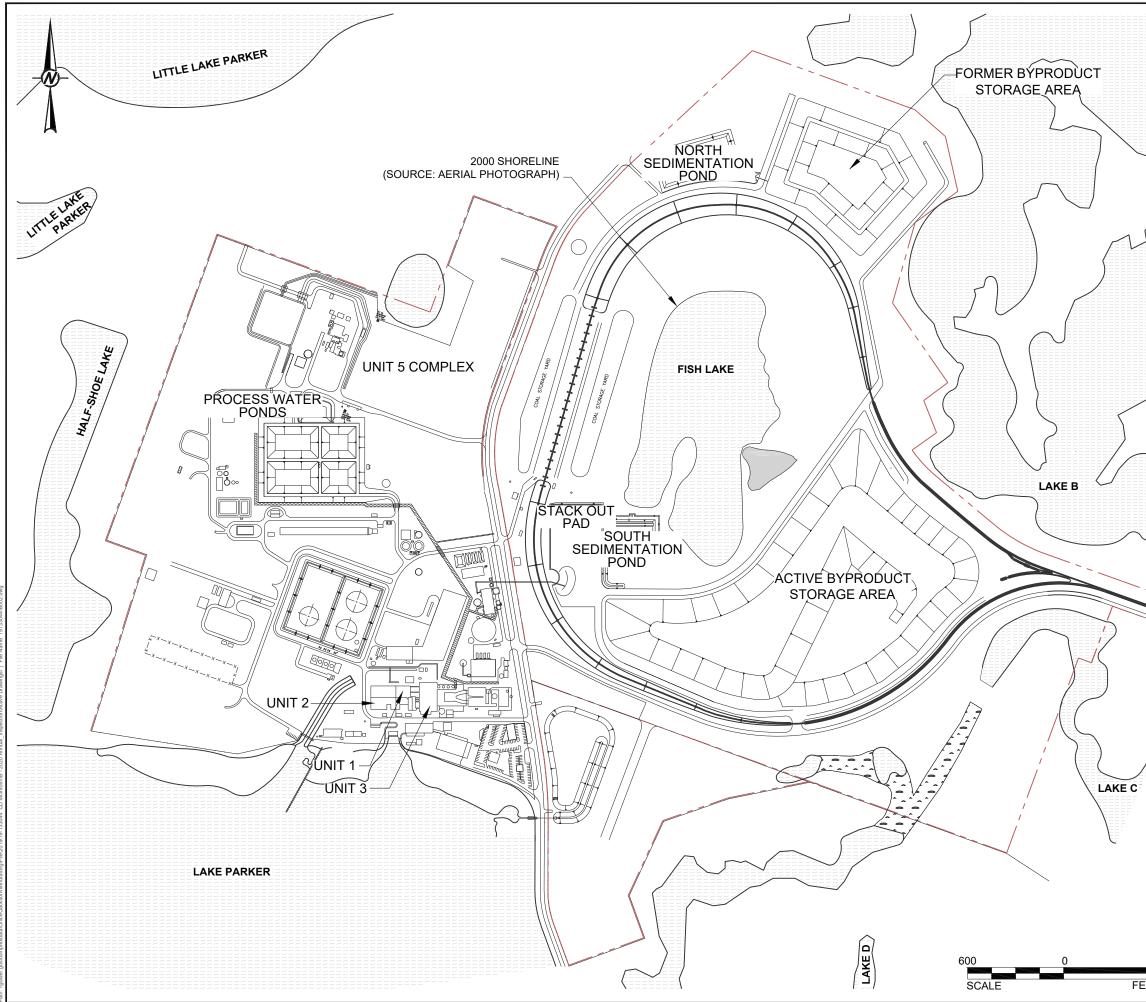
McINTOSH POWER PLANT SITE PLAN

1. BASE MAP MODIFIED FROM SITE PLAN PROVIDED BY LAKELAND ELECTRIC.

The MPP, located in Lakeland, Florida (See Figure 1) is owned and operated by Lakeland Electric (City of Lakeland, Department of Electric Utilities). The main entrance of the facility is located at 3030 East Lake Parker Drive, Lakeland, Florida. The BSA is located in the southeast portion of the property and received CCRs generated by Unit 3, which was the only coal-fired electrical generating unit at MPP (see Figure 2). Unit 3 ceased generation in 2021 and is scheduled for demolition in 2022.
