ALTERNATE SOURCE DEMONSTRATION FOR RADIUM 226 & 228 IN GROUNDWATER BYPRODUCT STORAGE AREA C.D. MCINTOSH POWER PLANT

LAKELAND, POLK COUNTY, FLORIDA

June 10, 2019

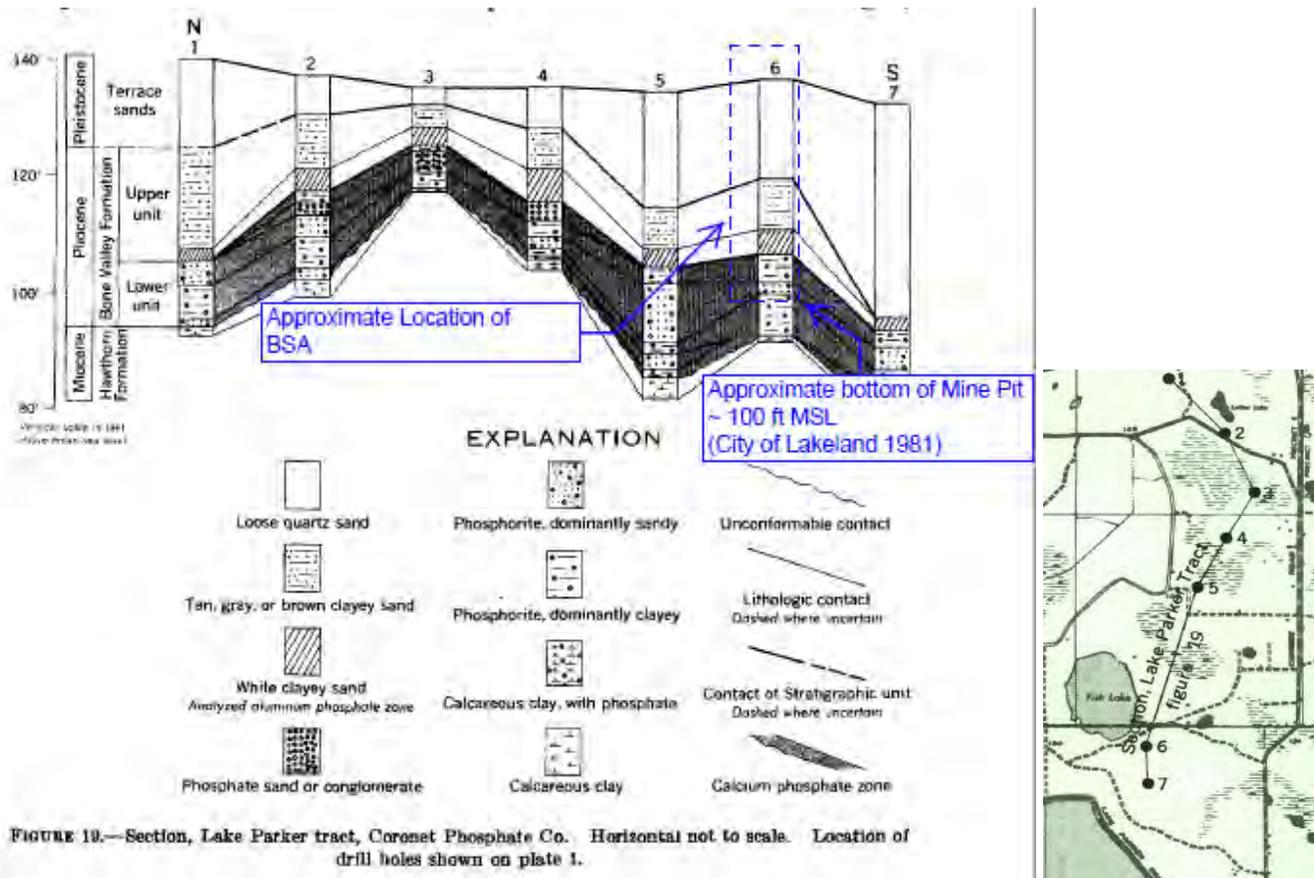
Source for above base imagery: Cathcart 1964 – Image to the right of the section depicts approximate section/drill hole locations from Plate 1. Drill hole locations #6 and #7 are nearest the BSA location. Appendix B to this report includes a copy of the City of Lakeland 1981 Landfill Design Survey Drawing No. 229101.

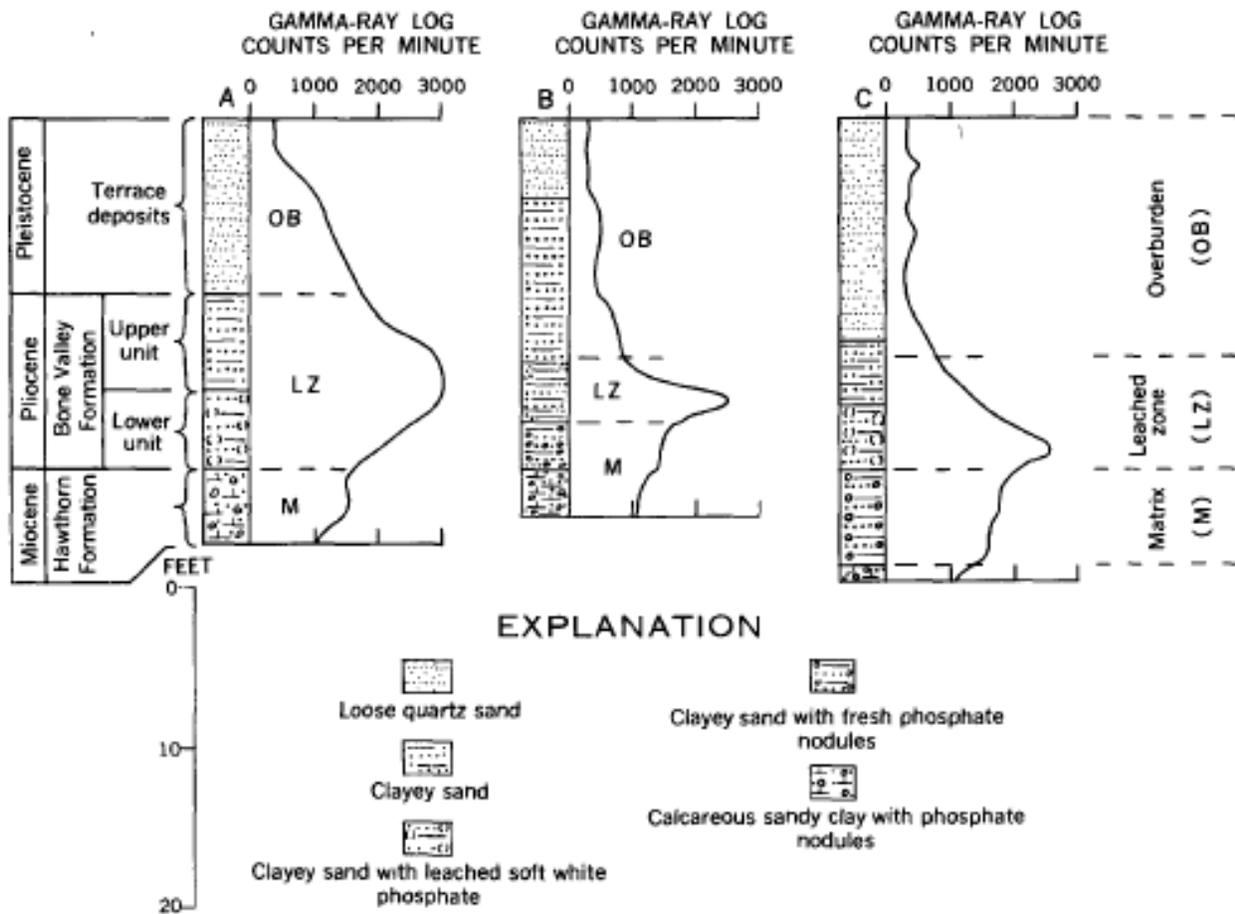
FIGURE 17.—Typical drill hole and gamma logs, Orange Park tract. Location of drill holes shown on plate 1.

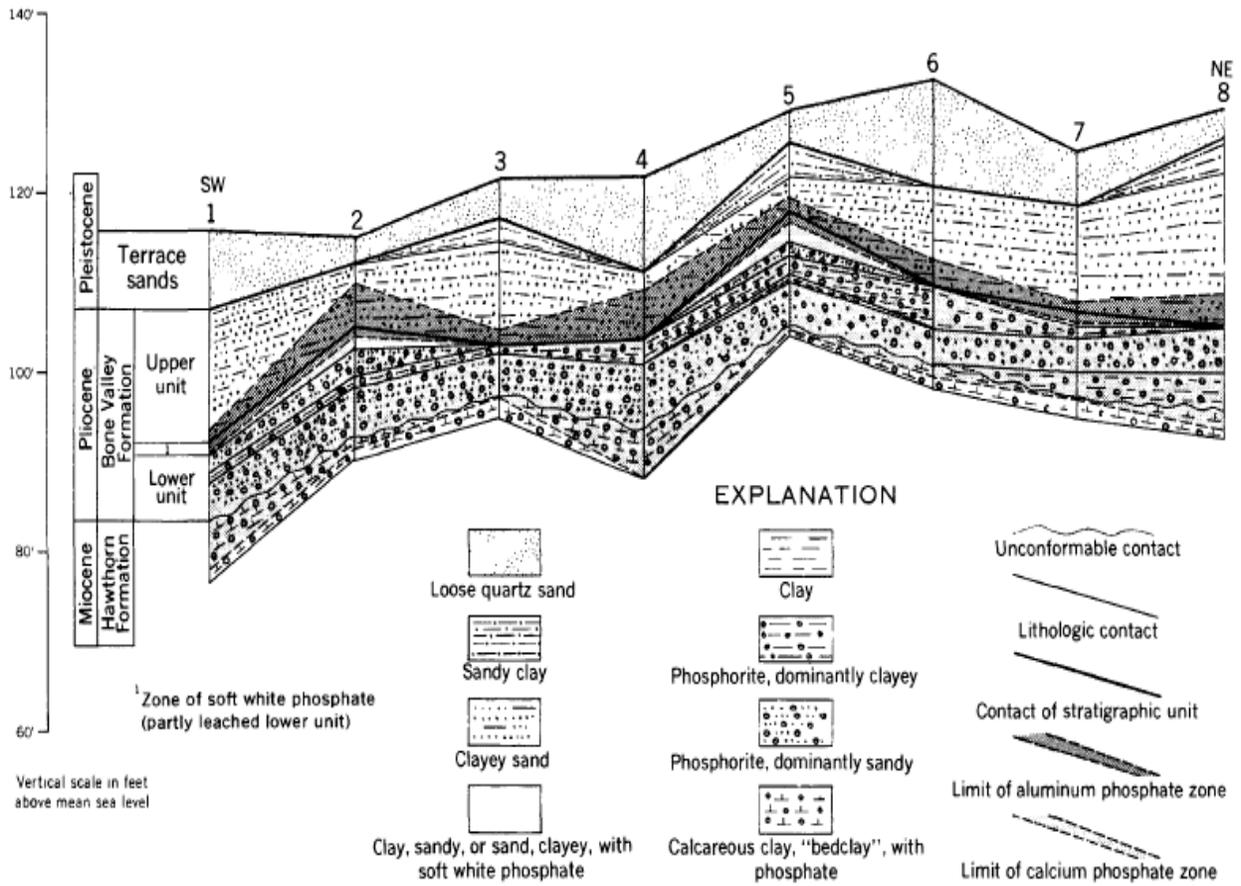
FIGURE 18.—Section, Tenoroc mine, showing relations of stratigraphy and economic geology. Horizontal not to scale. Location of drill holes shown on plate 1.

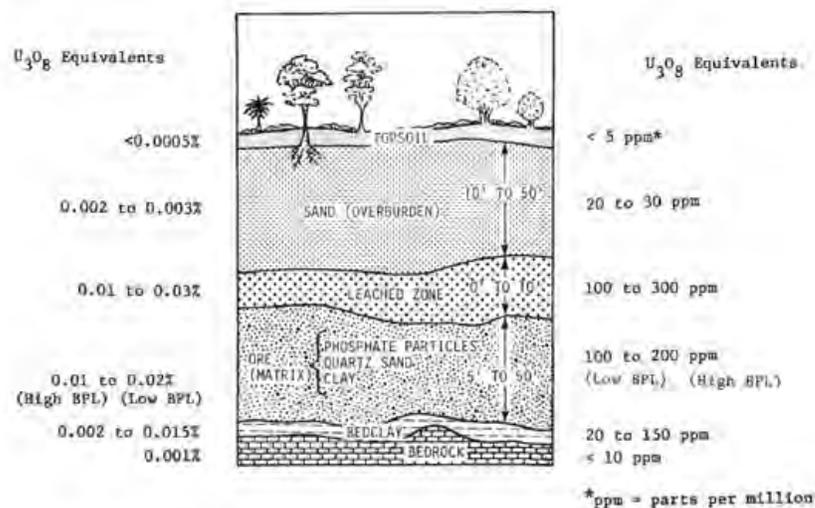
- A typical Central Florida Phosphate district profile with average uranium concentrations listed per stratum is depicted below:

Figure 1.15. Average Uranium Concentrations as U₃O₈ (Altschuler et al 1956, Cathcart 1965, McKelvey 1956) in Typical Central Florida Phosphate District Profile (Pountain and Zellars 1972)

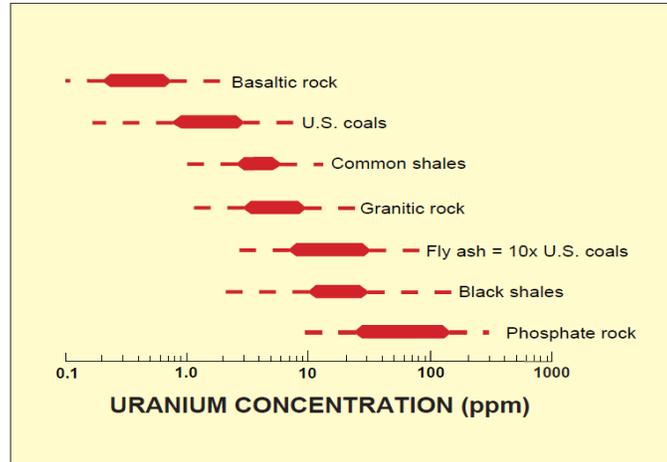
- Uranium in leached- and matrix-zones exhibits typical concentrations between 100 and 300 parts per million (ppm), which is approximately 1 to 2 orders of magnitude higher than U.S. coals and fly ash, respectively, as depicted below (USGS 1997, Figure 2):

Figure 2. Typical range of uranium concentration in coal, fly ash, and a variety of common rocks.

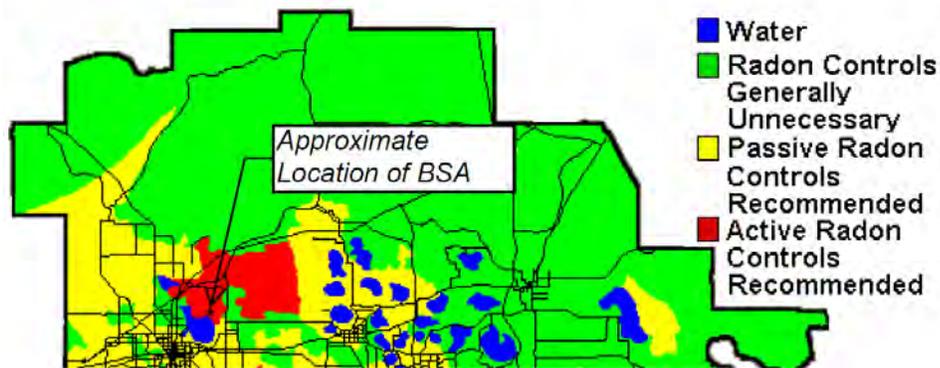
- According to the Florida Department of Health (FDOH), the MPP is located in an area that is known to contain so much naturally-occurring radon, which is a daughter product of radium-226 decay, that the FDOH suggests buildings designed for construction on reclaimed mined land include active engineering controls in the effort to mitigate potential adverse health effects associated with human exposure to the natural radon gas. The following image is an excerpt from the Radon Protection Map for Polk County and depicts the approximate location of the BSA.

Source of above image of northern Polk County: http://www.floridahealth.gov/environmental-health/radon/maps/_images/POLK_LB.GIF (accessed November 16, 2018).

- Elevated levels of radon in structures built on reclaimed land suggest uranium and radium concentrations at shallow depths may be elevated relative to pre-mining levels. This is considered to occur when discarded fine-grained ore and leach zone materials are mixed with overburden materials as part of overall reclamation (Kaufman and Bliss 1977).

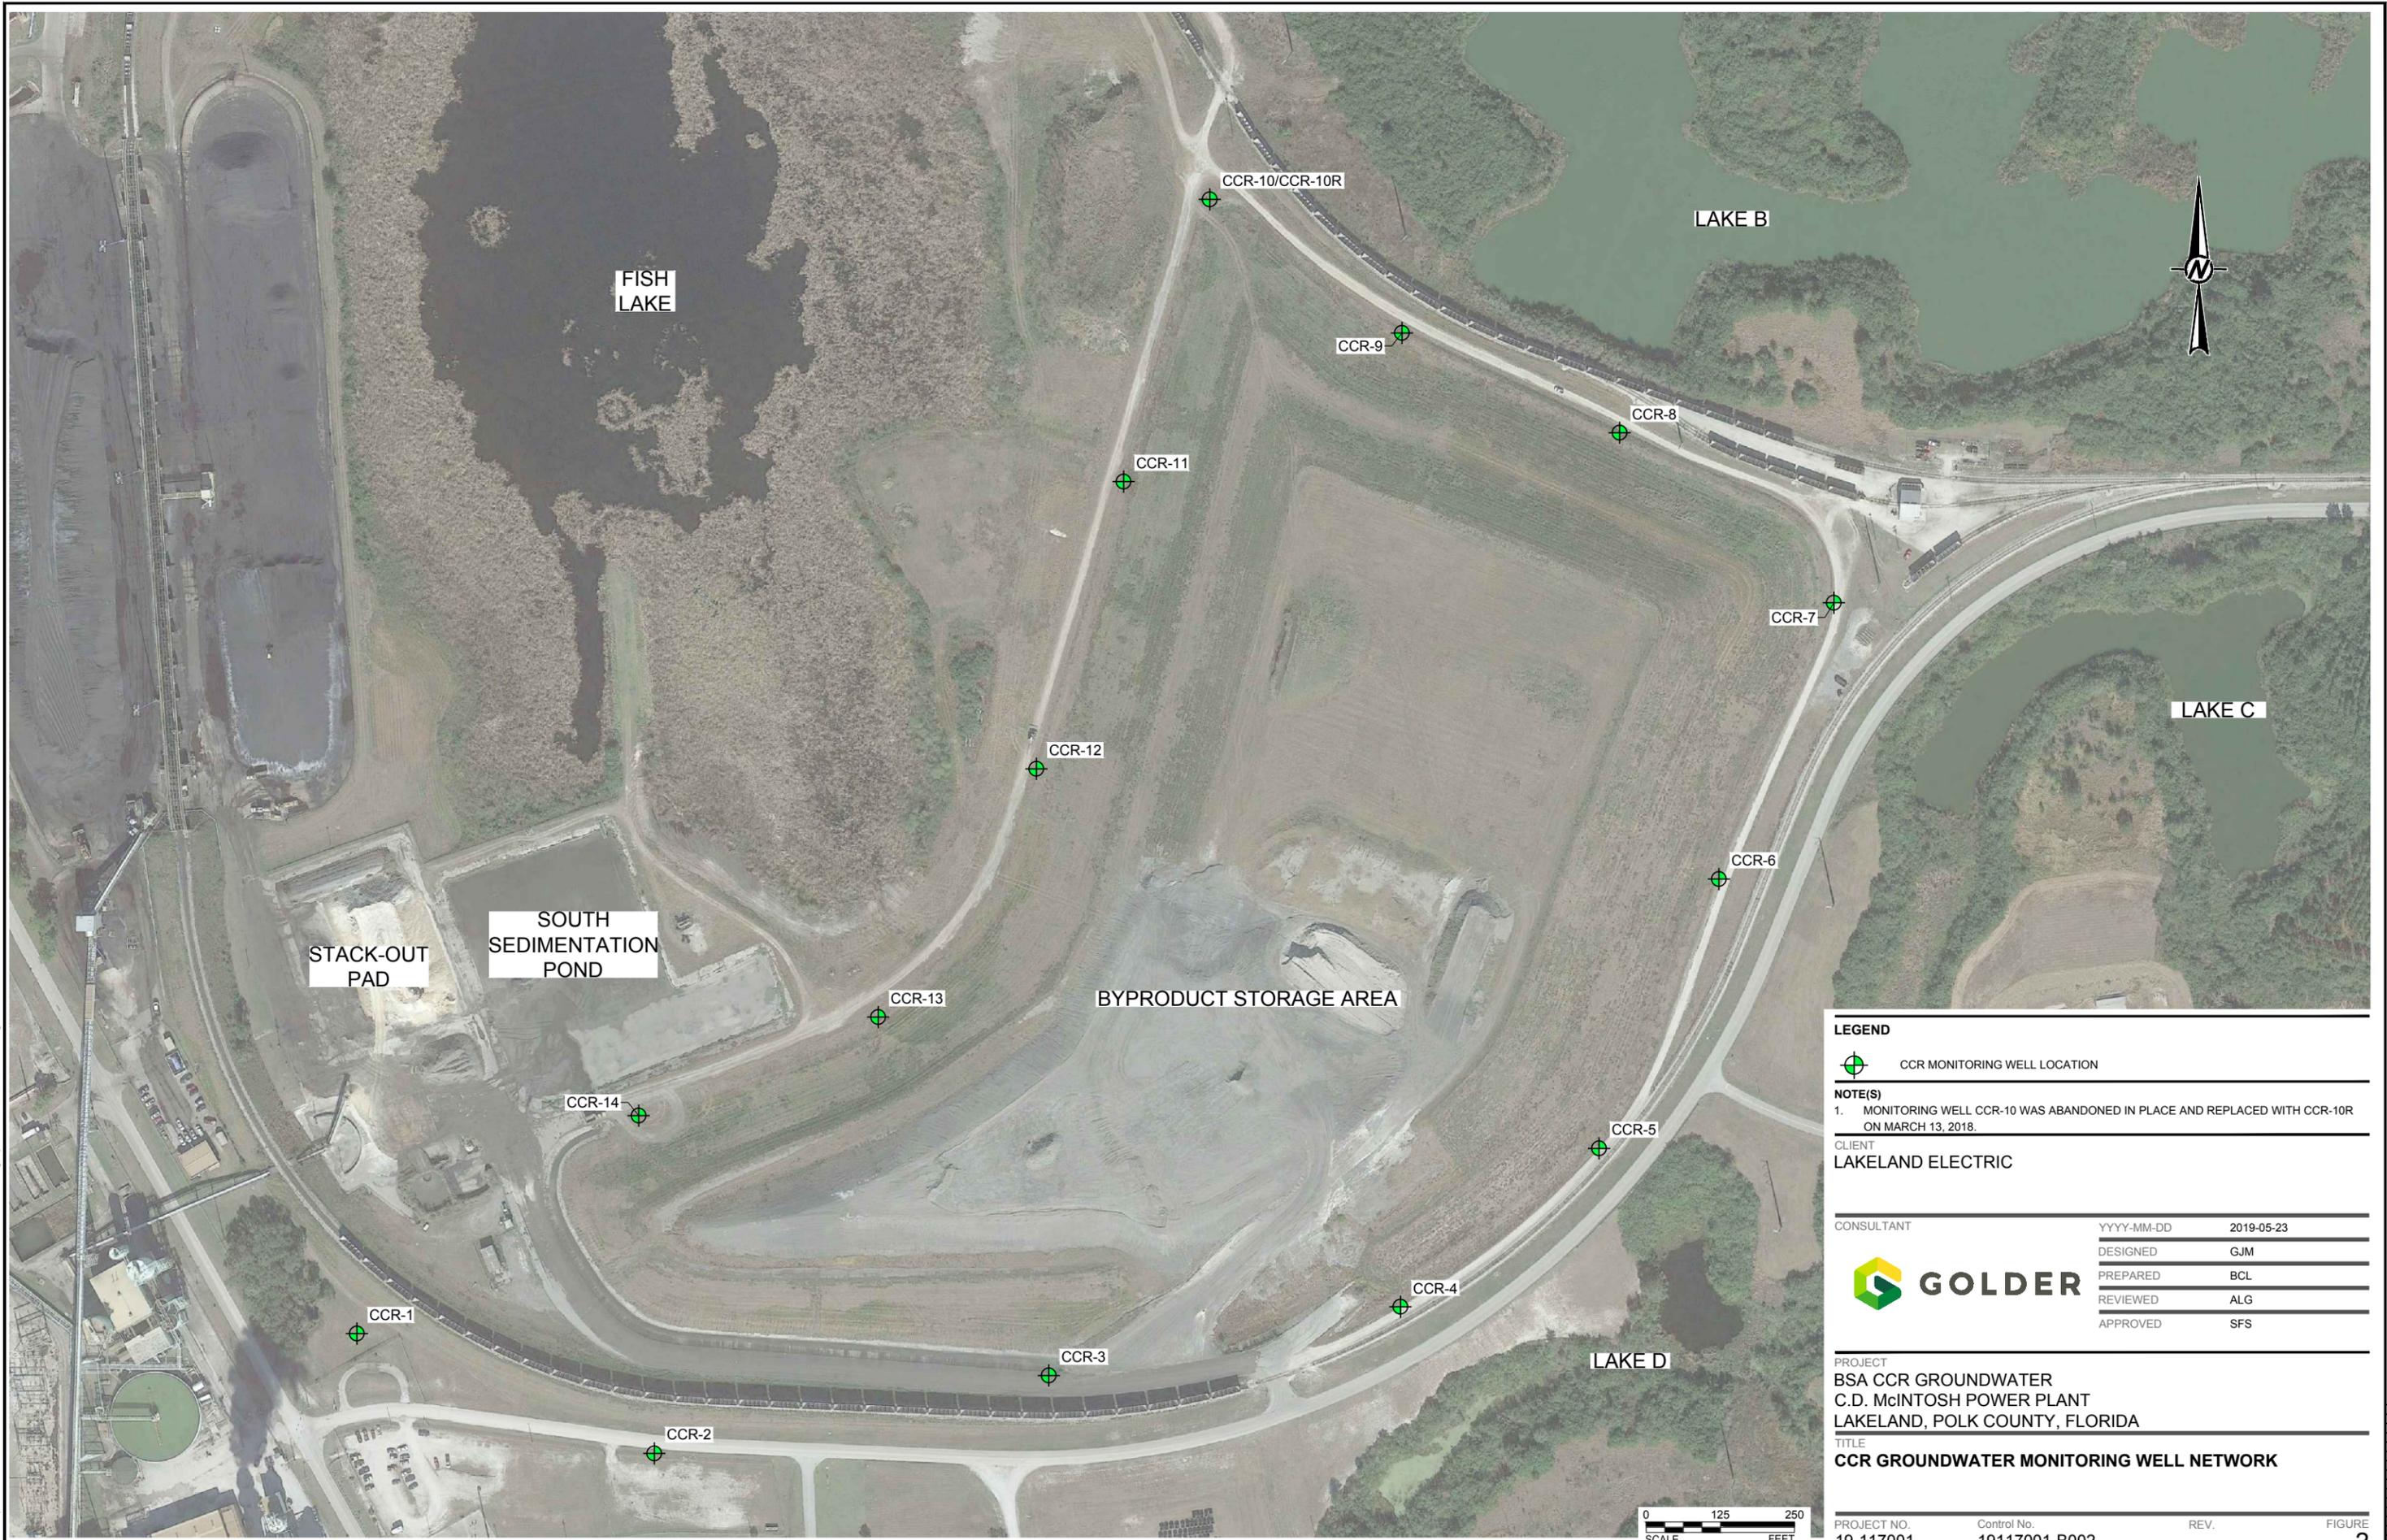
| PROJECT NO. 19-117001 | Control No. 19117001-B002 | REV. | FIGURE 2 |

1. MONITORING WELL CCR-10 WAS ABANDONED IN PLACE AND REPLACED WITH CCR-10R ON MARCH 13, 2018.

TITLE
CCR GROUNDWATER MONITORING WELL NETWORK

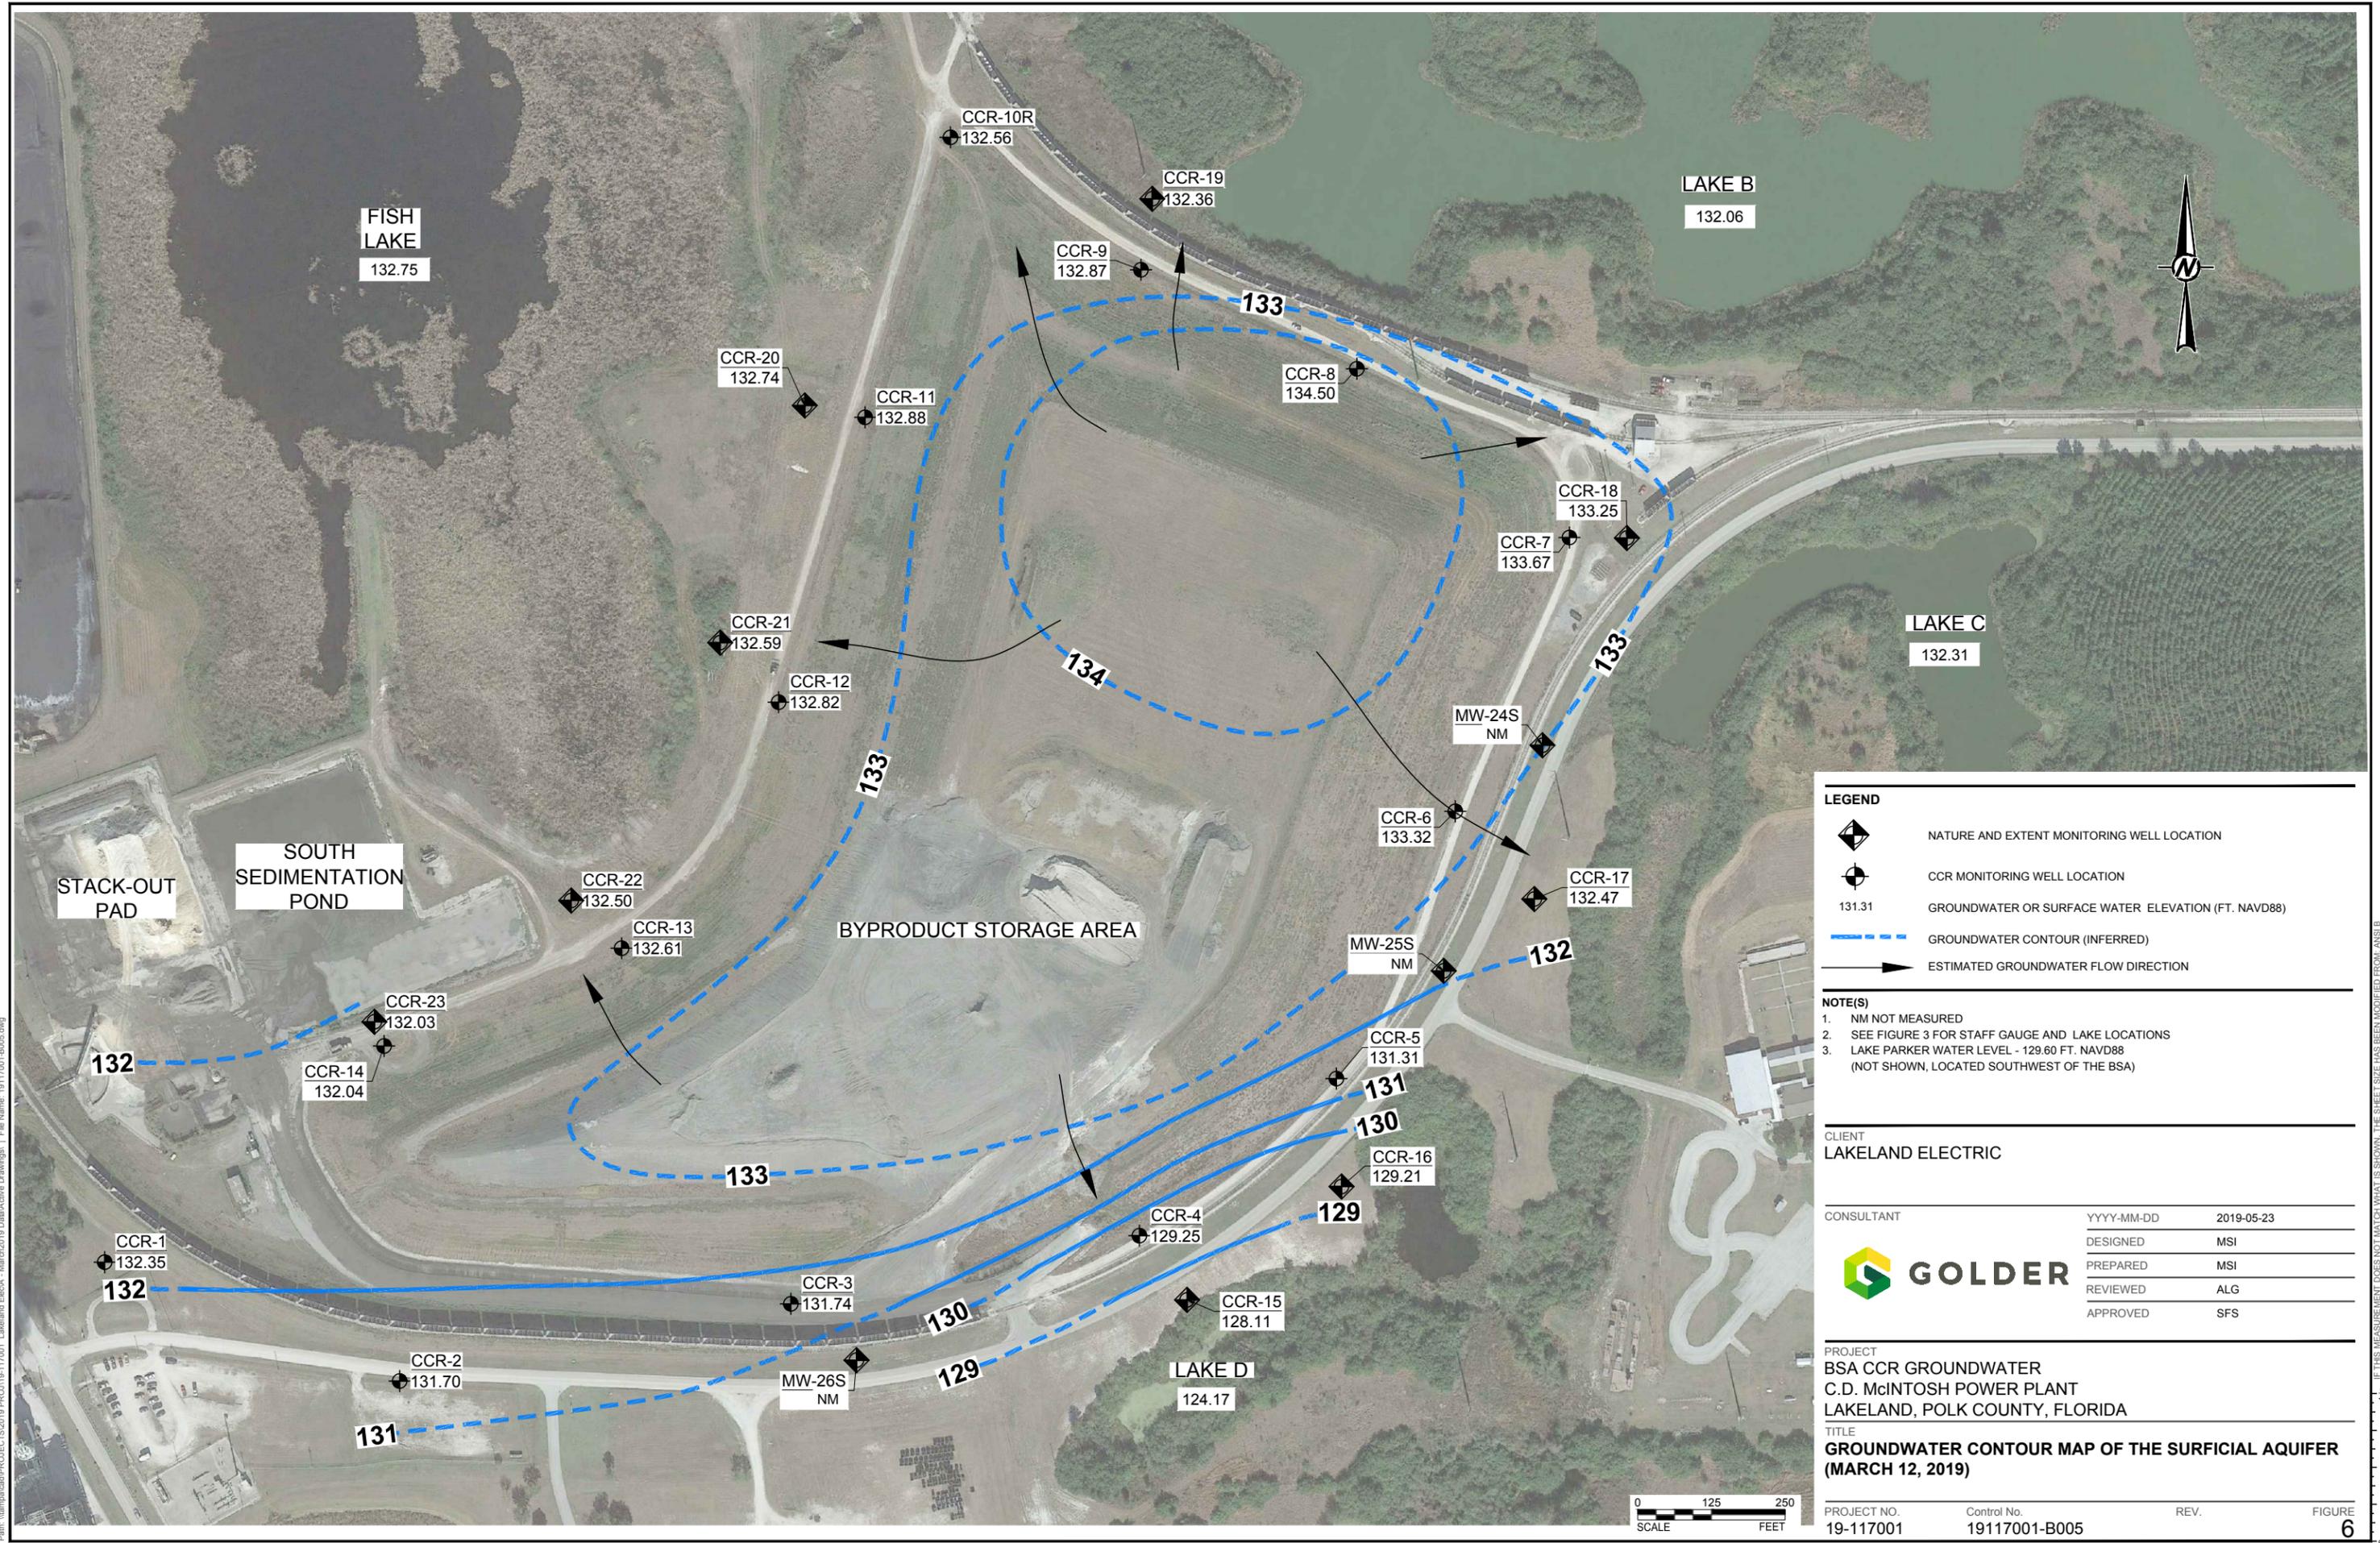
- NATURE AND EXTENT MONITORING WELL LOCATION
- CCR MONITORING WELL LOCATION
- 131.31 GROUNDWATER OR SURFACE WATER ELEVATION (FT. NAVD88)
- GROUNDWATER CONTOUR (INFERRED)
- ESTIMATED GROUNDWATER FLOW DIRECTION

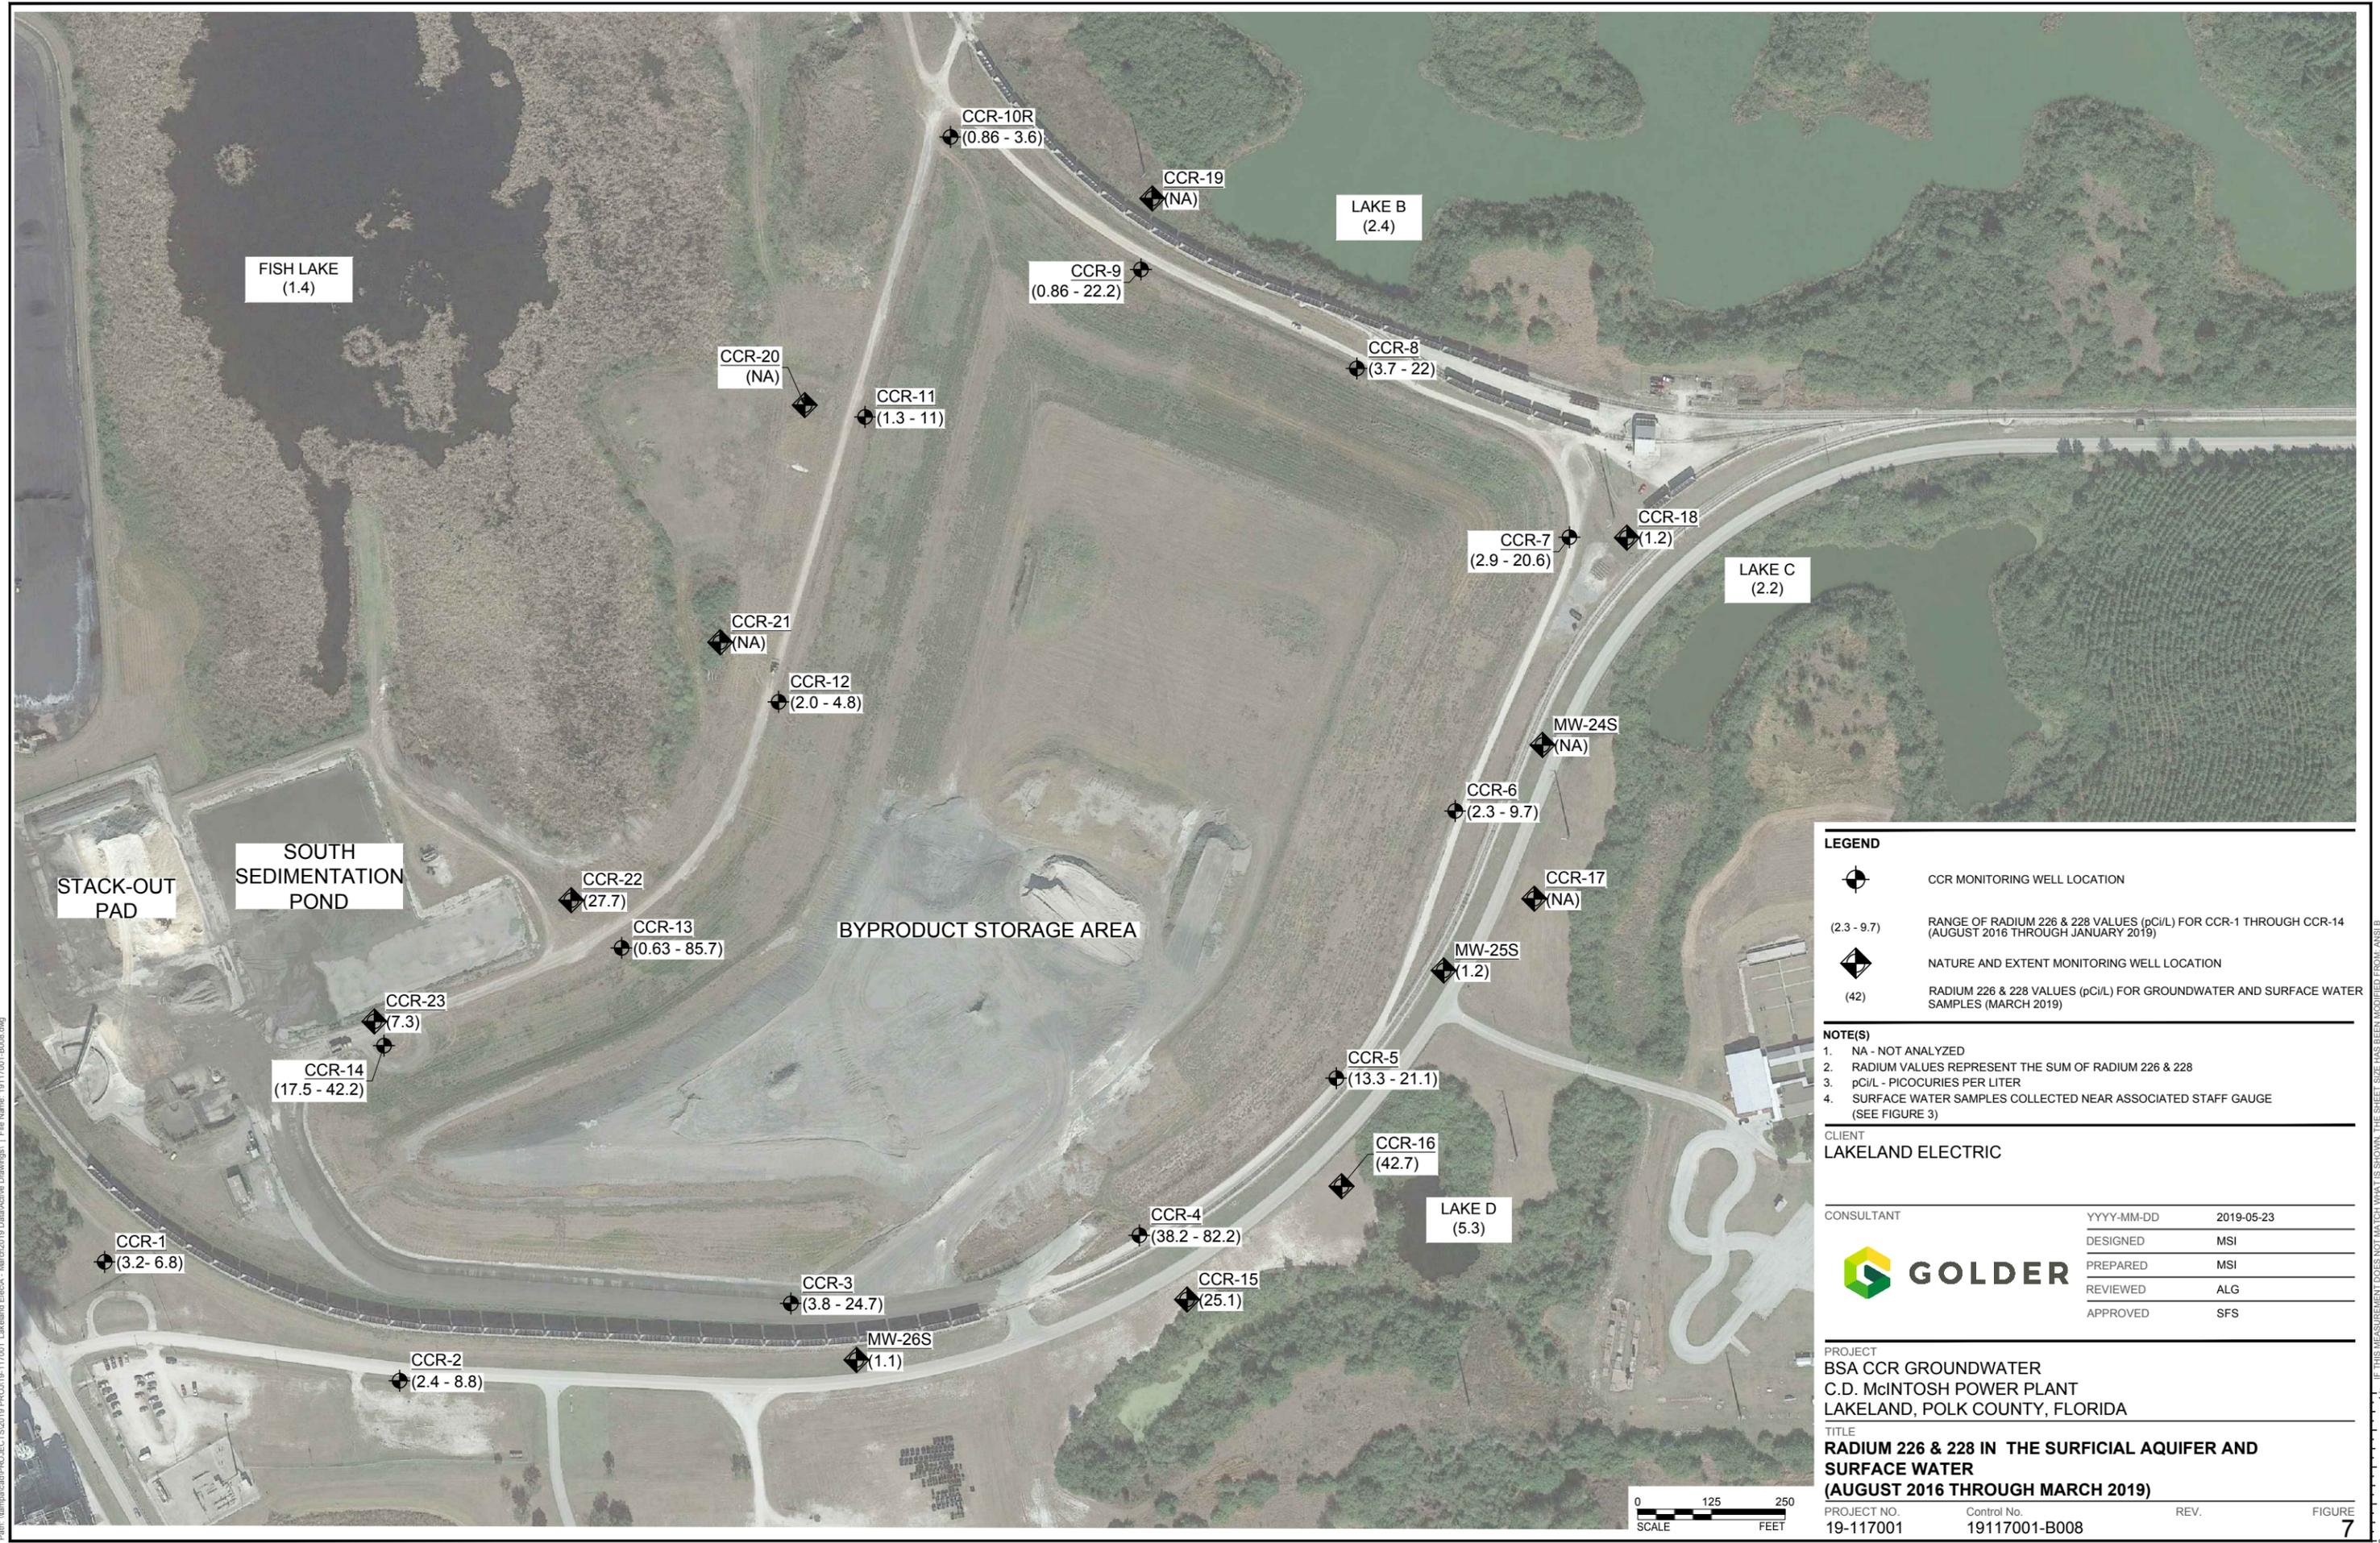
- CCR MONITORING WELL LOCATION
- RANGE OF RADIUM 226 & 228 VALUES (pCi/L) FOR CCR-1 THROUGH CCR-14 (AUGUST 2016 THROUGH JANUARY 2019)
- NATURE AND EXTENT MONITORING WELL LOCATION
- RADIUM 226 & 228 VALUES (pCi/L) FOR GROUNDWATER AND SURFACE WATER SAMPLES (MARCH 2019)

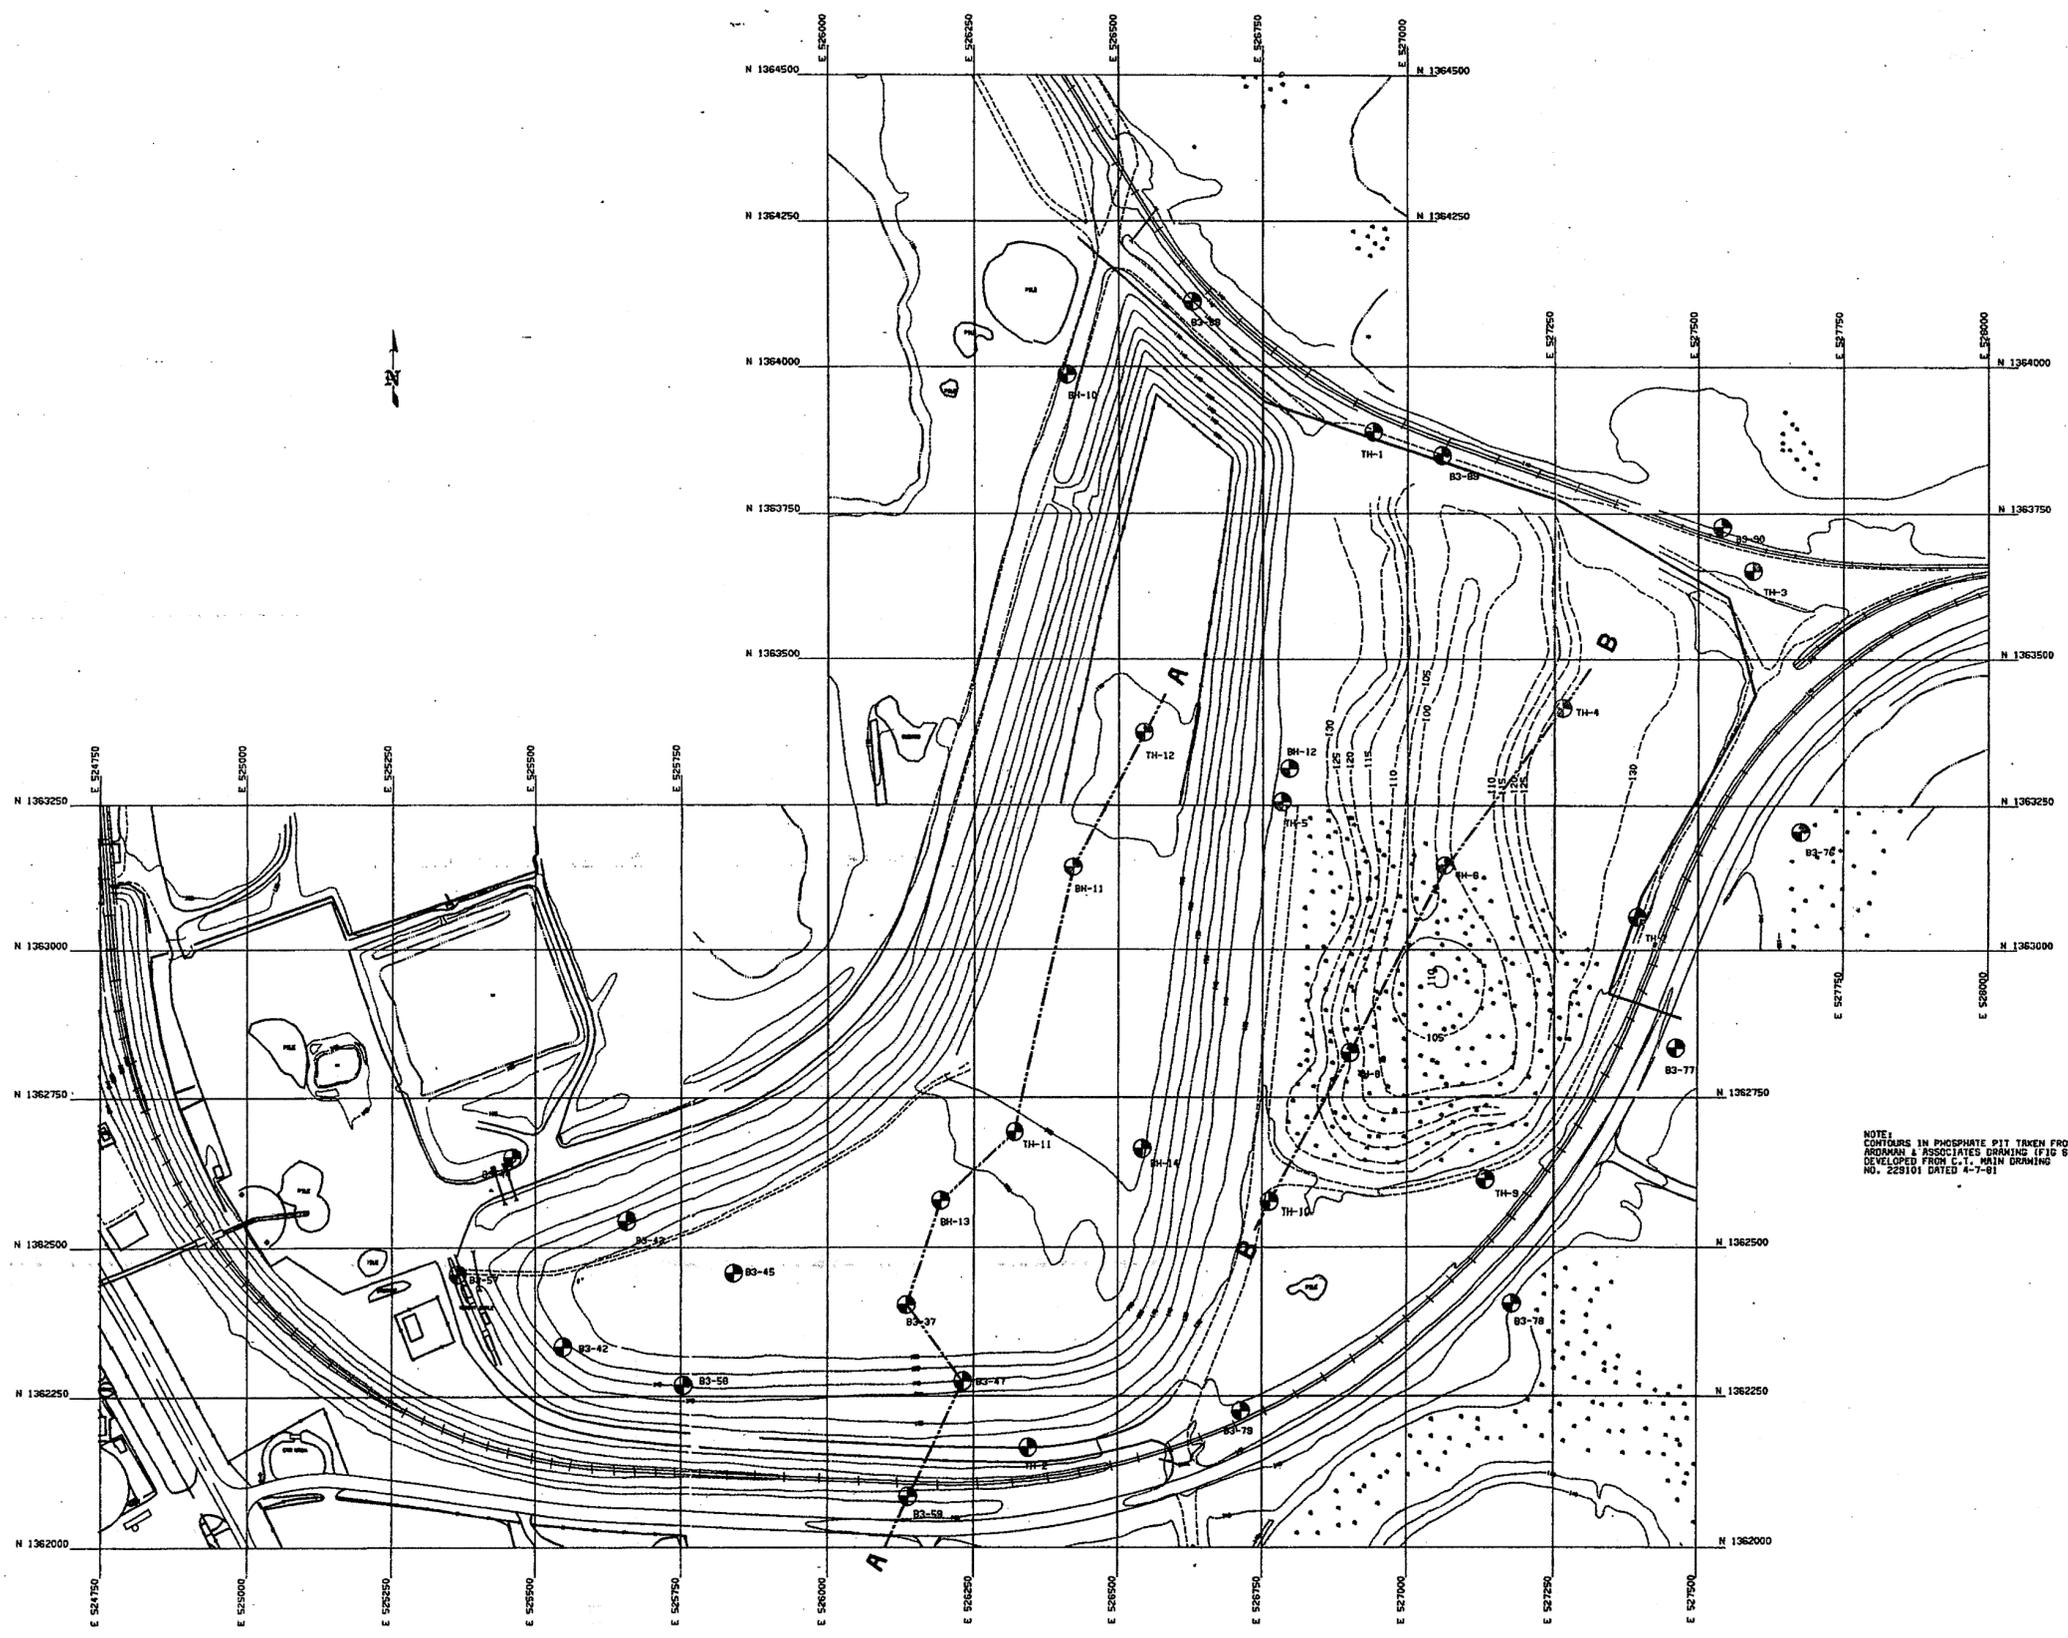
PROJECT: 17757
 DRAWING NUMBER: A
 CODE: _____
 DATE: _____
FIGURE 2-1

NOTE:
 CONTOURS IN PHOSPHATE PIT TAKEN FROM
 ARDMAN & ASSOCIATES DRAWING (FIG 6-1)
 DEVELOPED FROM C-1, MAIN DRAWING
 NO. 229101 DATED 4-7-81

SOIL BORING LOCATION PLAN
