ALTERNATE SOURCE DEMONSTRATION FOR RADIUM 226 & 228 IN GROUNDWATER BYPRODUCT STORAGE AREA C.D. MCINTOSH POWER PLANT

LAKELAND, POLK COUNTY, FLORIDA

June 10, 2019

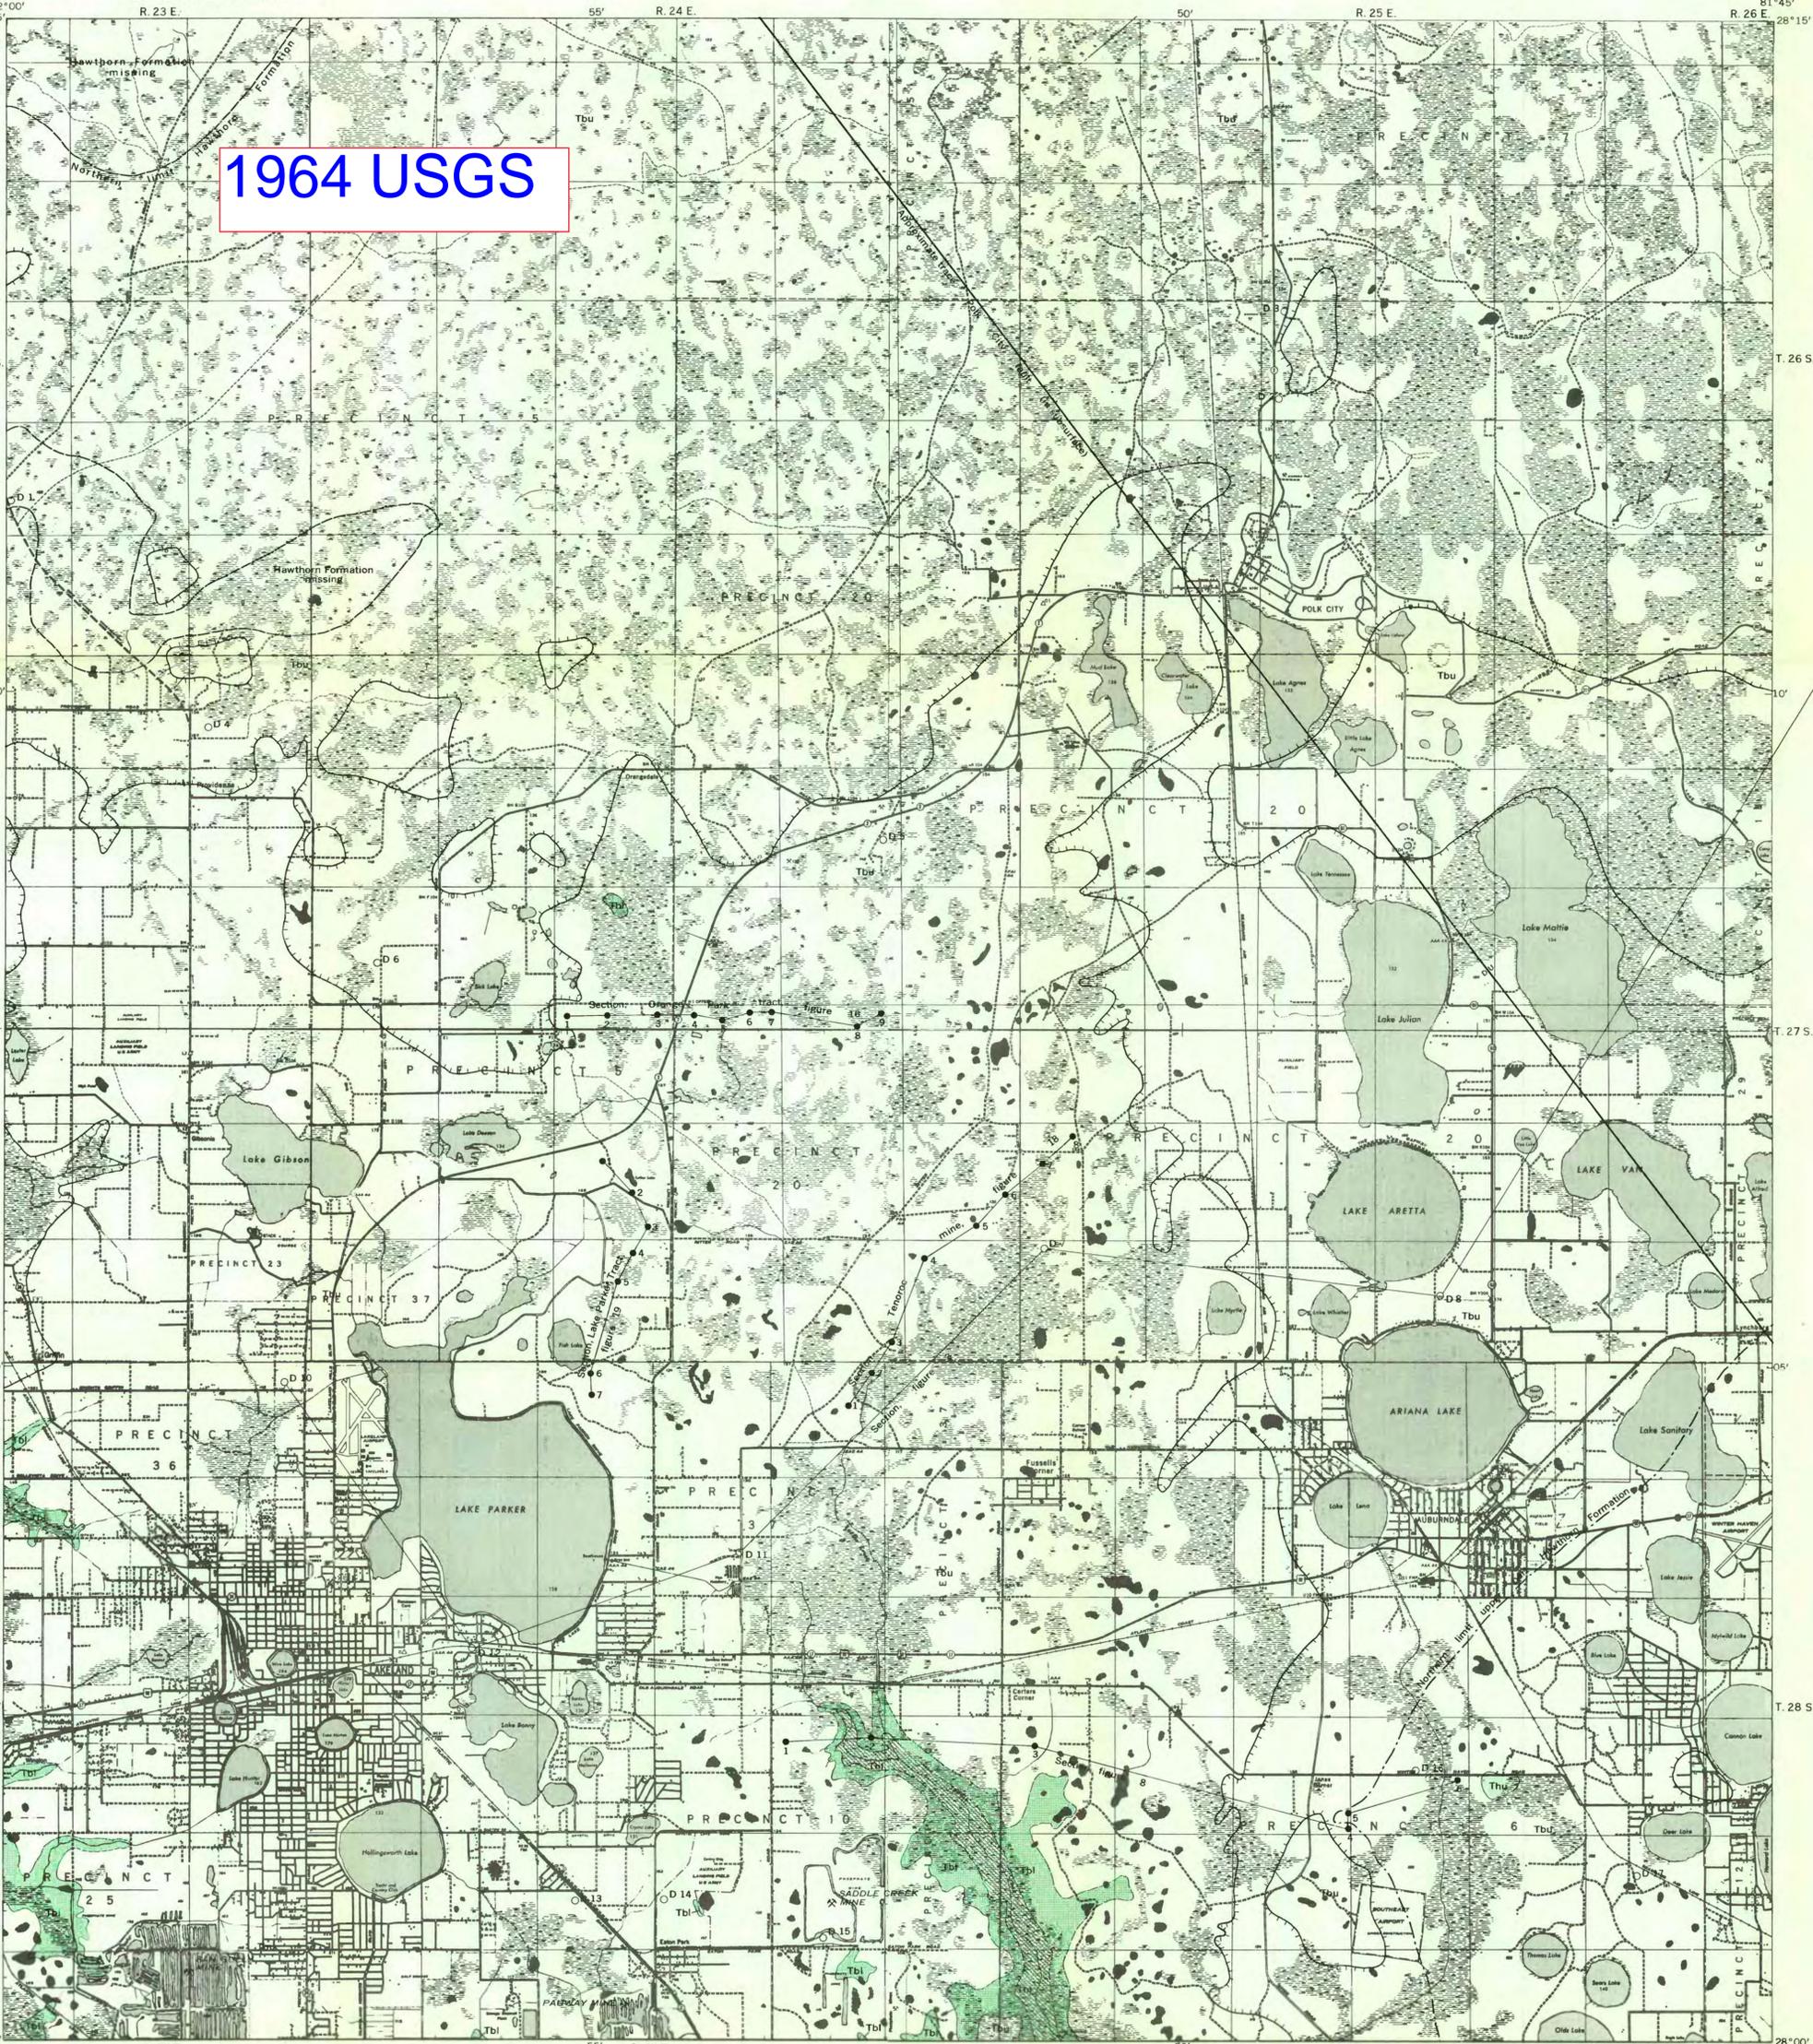
Loose quartz sand of Pleistocene and Recent age not shown

GEOLOGIC MAP OF THE LAKELAND QUADRANGLE, FLORIDA

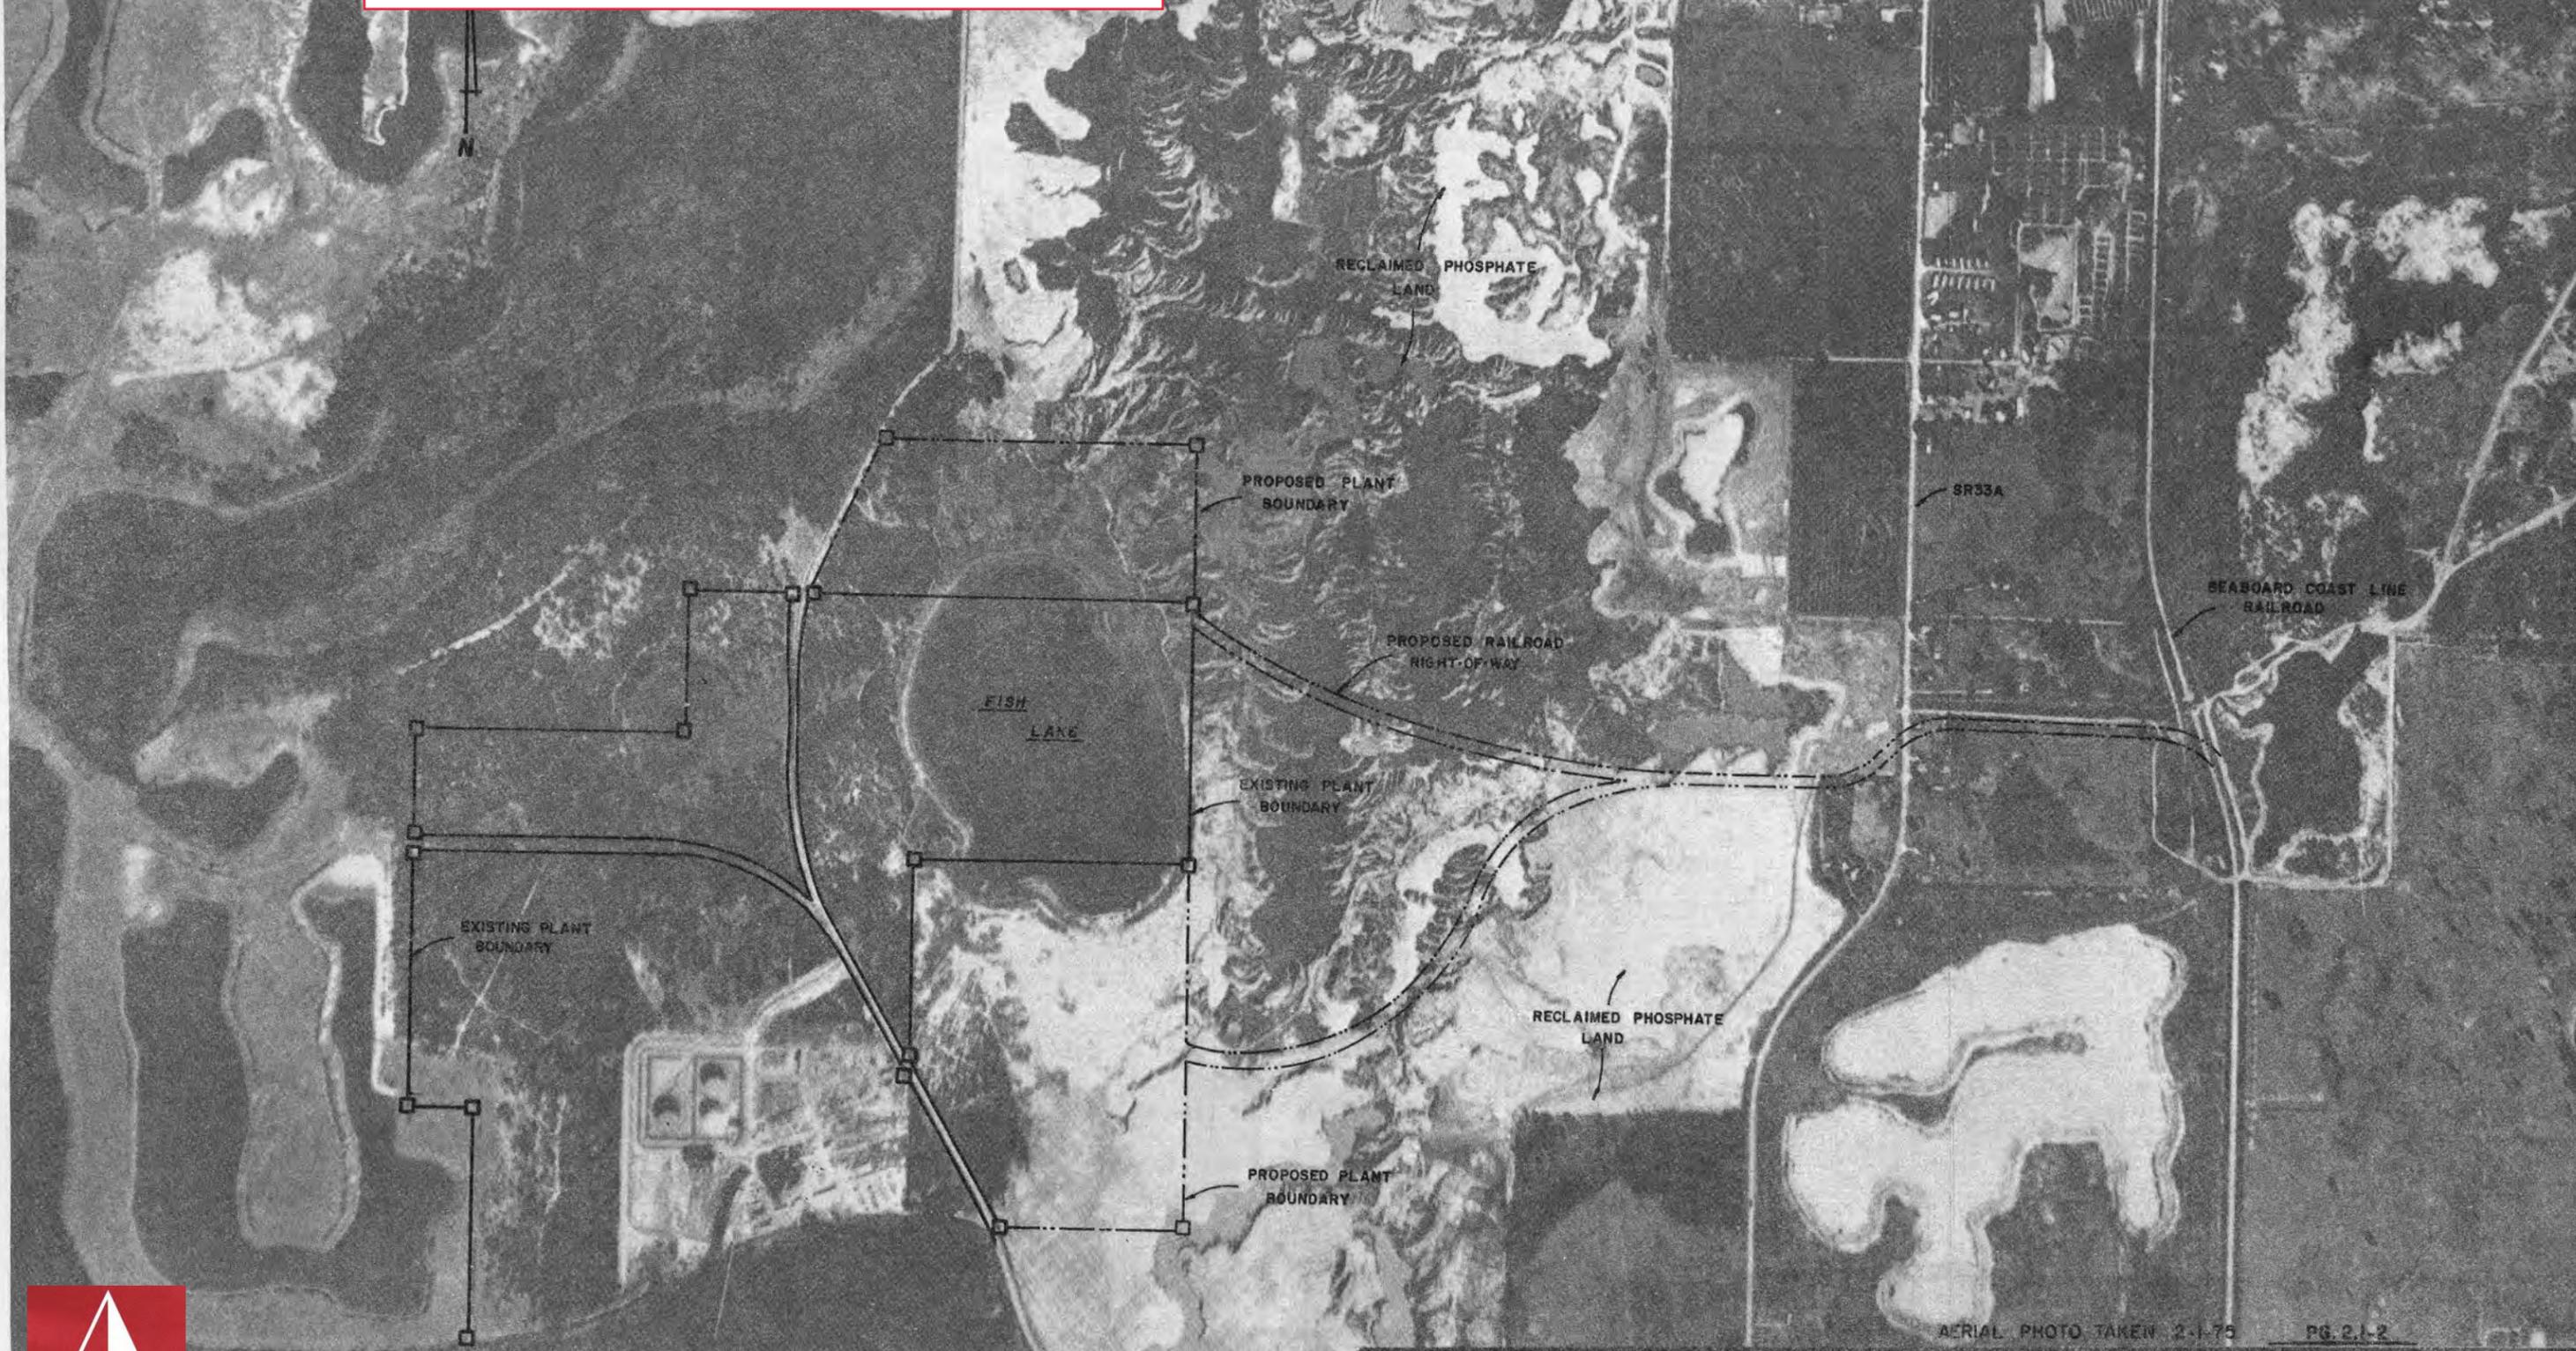
| App. by | | AERIAL TOPOGRAPHICAL MAP | | MAP 2.1.1 | |

AERIAL PHOTO TAKEN 2-1-75 PG. 2.1-2

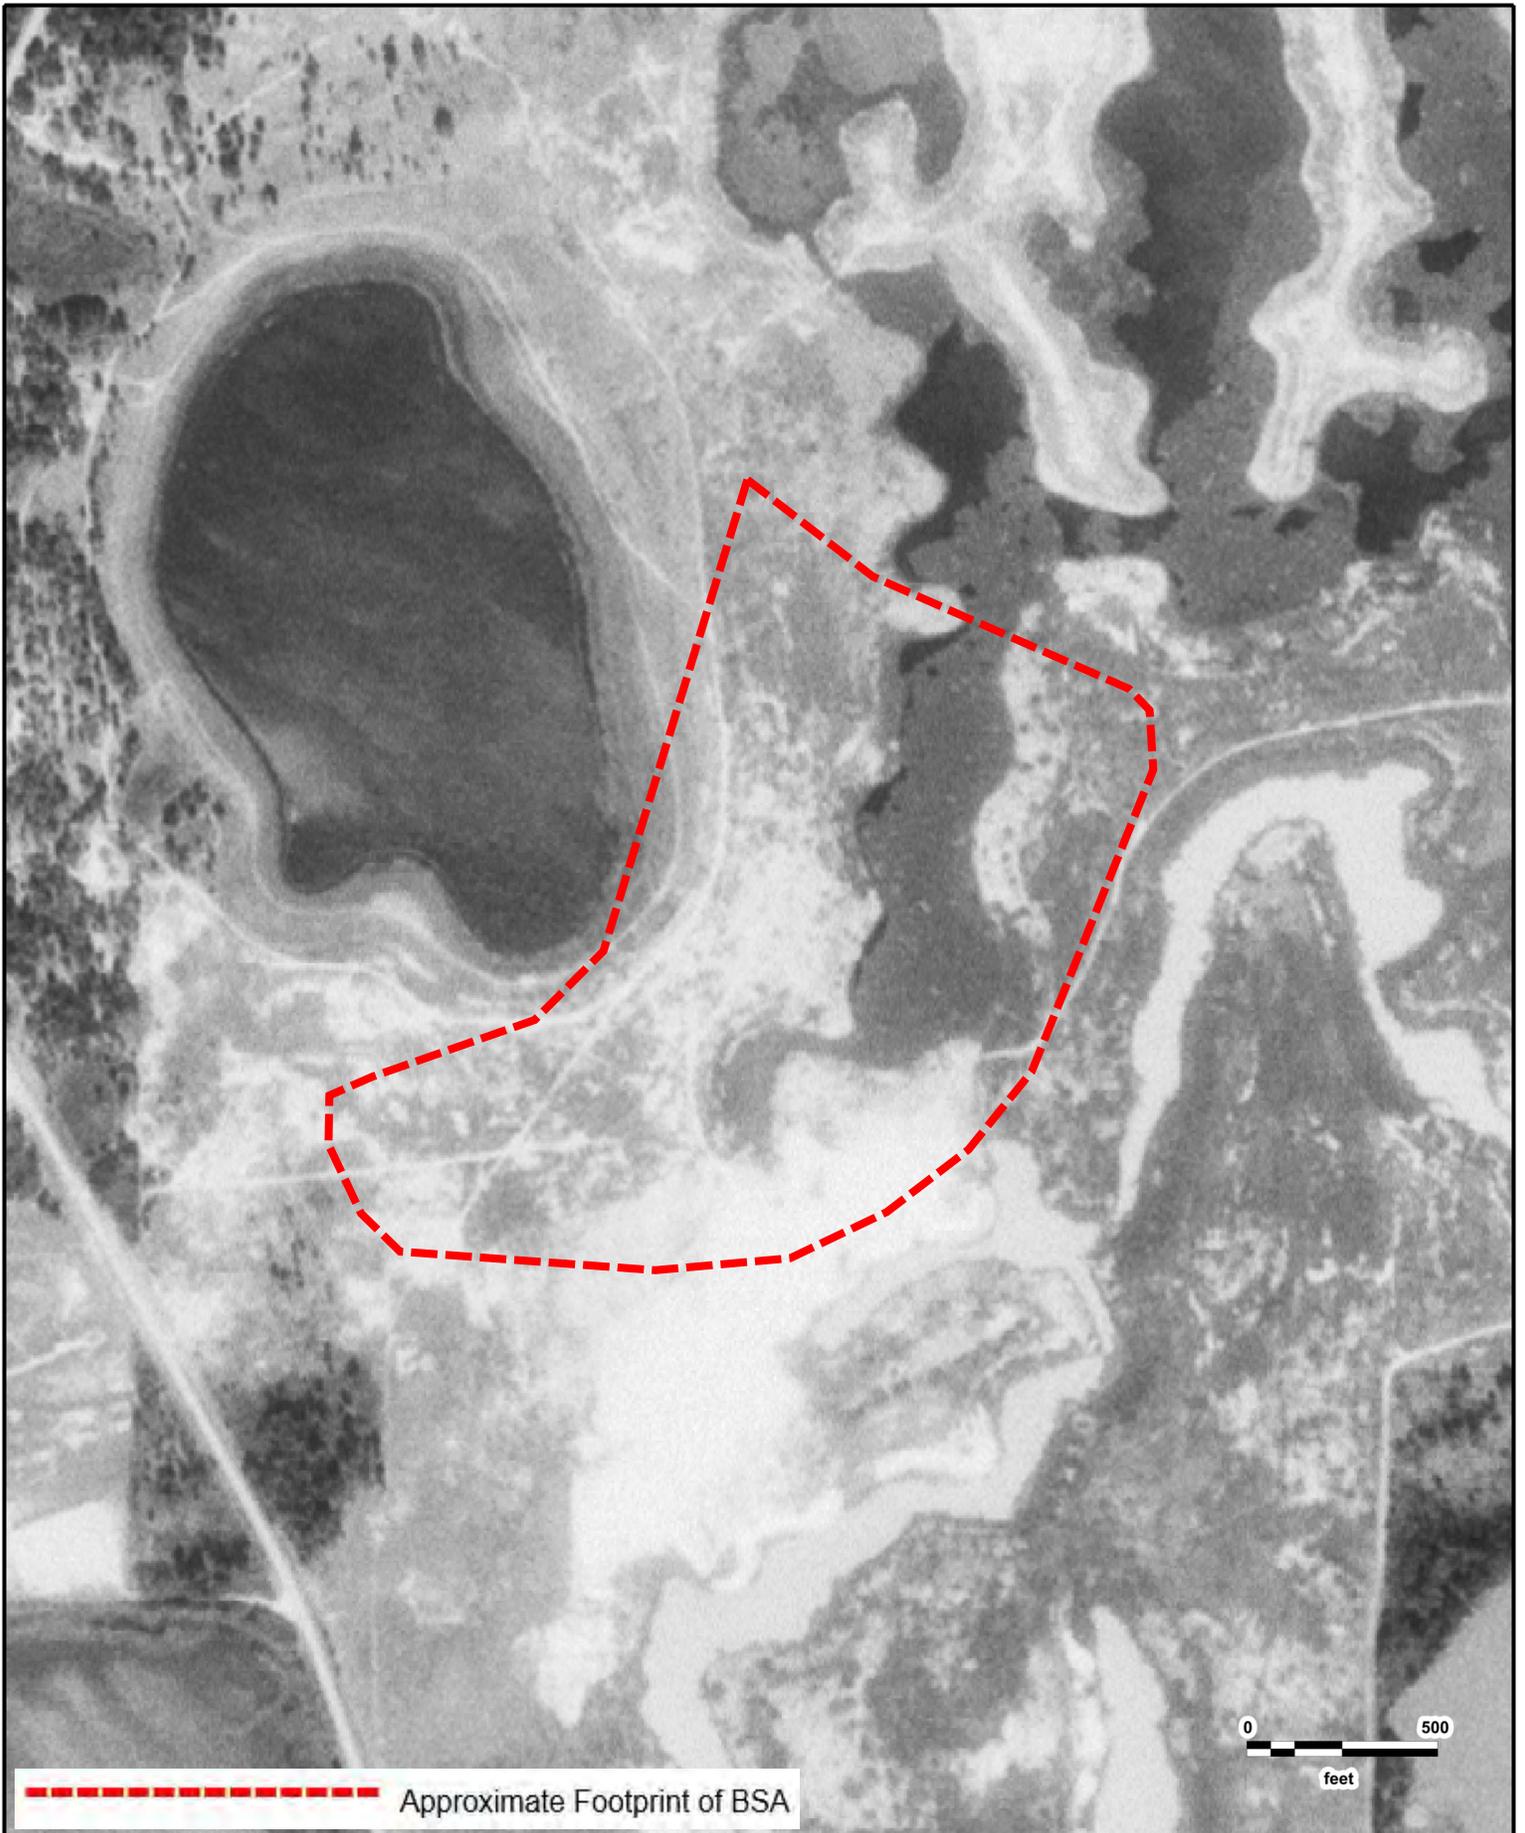
BSA at Lakeland Electric USGS
11/26/1977
(Current boundary shown by dashed red line)

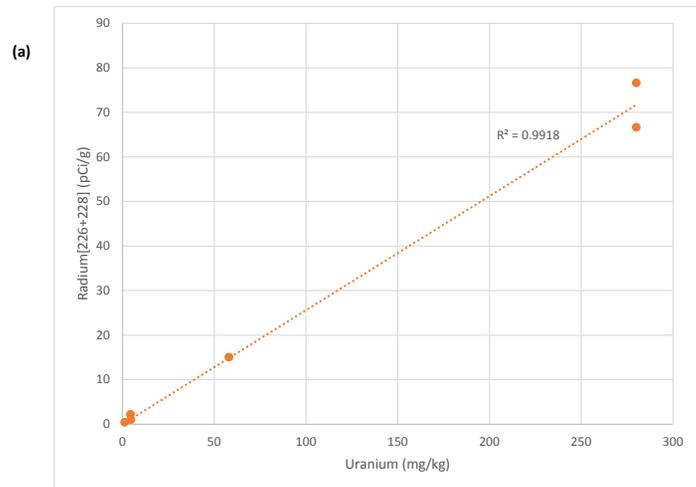
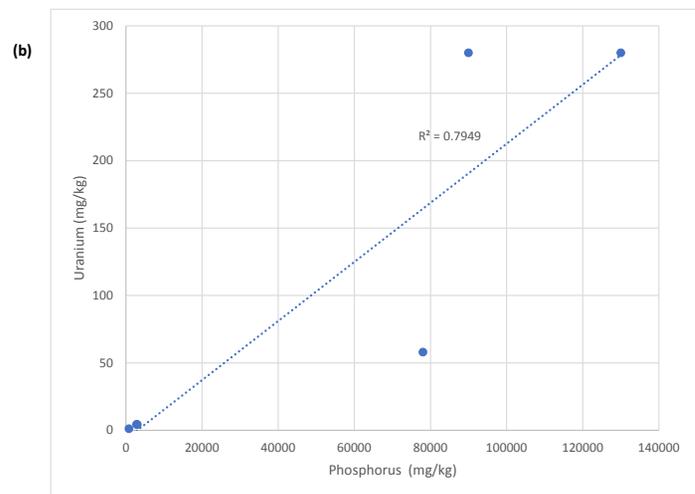
Results of chemical analysis of soils from boreholes for radionuclides and phosphorus

These soil and groundwater findings support the literature review indicating that the BSA and surrounding area are underlain by fine-grained phosphatic mine tailings and/or unmined phosphate deposits. Based on those findings, there is the high likelihood that radium-226+228 detected in groundwater is present as a product of the decay of a naturally-occurring uranium and thorium in soil and/or the mine tailings/phosphate deposits.
